Access Compliance Report Public Rights-of-Way (Curb Ramps)

· · · · · · · · · · · · · · · · · · ·								
Intersection ID: N/A	Main Street: COPPER_WY		Cross Street: N/A				Location:	NW
ADA ID: 77226A3F428B	Ramp Type: PerpDiag	Initial	Initial Pass/Fail: Fail Overall Compliance: No				o Severity Score:	8.75
Codes/Mitigation Info/Possible Solution			Field Measurements/Component Compliance					
	Possible Solutions:					liance Description	Data	
	Remove & Replace Curb R	Ramp With	N/A	Ramp Length (in)	73.0	Yes	Ramp Slope (%)	7.3
	Two New Directional Ram		No	Ramp Width (in)	47.0	Yes	Ramp XSlope (%)	1.7
	Equivalent.		N/A	Flare Type LT	N/A	N/A	Flare Type RT	N/A
			N/A	Flare Slope LT (%)	N/A	N/A	Flare Slope RT (%)	N/A
	I have to		N/A	Flare Traversable LT?	N/A	N/A	Flare Traversable RT?	N/A
			N/A	Landing Length (in)	N/A	N/A	DWS Provided?	N/A
	Surveyor Notes:		N/A	Landing Width (in)	N/A	N/A	DWS Contrast?	N/A
	N/A		N/A	Landing Slope (%)	N/A	N/A	DWS Length (in)	N/A

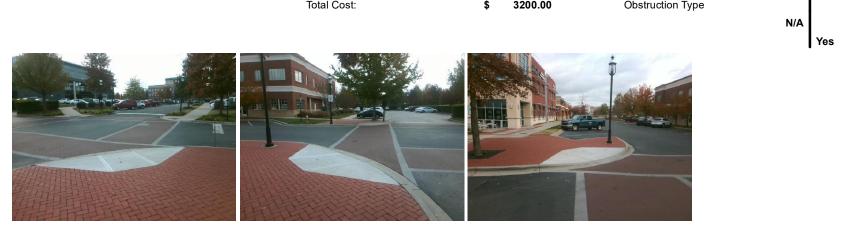
6. 1 6		N/A	Landing X Slope (%)	N/A	N/A	DWS Full Width?	N/A
No state of the			N/A	Landing Curb? (Y/N)	N/A	N/A	DWS Offset (in)	N/A
THE GEL	5.		N/A	Shared Landing?	N/A		()	
	PROW/ADA:		N/A	Gutter Ponding?	N/A	N/A	Gutter Slope (%)	N/A
	Not Found, R304.5.1		N/A	Gutter Lip Ht (in)	N/A	N/A	Gutter X Slope (%)	N/A
	Not i bund, Robels.		N/A	Painted X Walk1?	Yes	N/A	Painted X Walk2?	Yes
				X Walk 1 Direction	To SW		X Walk 2 Direction	To SE
			N/A	X Walk 1 Width (in)	102.0	N/A	X Walk 2 Width (in)	101.0
Street 1 Name	ENTRANCE			X Walk 1 Slope (%)	2.3		X Walk 2 Slope (%)	3.1
Stop Condition-Street 2	StopSign			X Walk 1 X Slope (%)	4.0		X Walk 2 X Slope (%)	0.4
Street 2 Name	COPPER WY		N/A	Ramp inside XWalk1?	Yes	N/A	Ramp inside XWalk2?	Yes
Stop Condition-Street 1	None			Road Slope (%)	0.5	N/A	Clear Space?	N/A
				Road X Slope (%)	2.2	N/A	Clear Space to XWalk (in)	N/A
			N/A	Any Obstructions?	2.2 N/A	N/A	Storm Grate/Utility Hazard?	N/A

Total Cost:	\$ 3200.00	11/1	Obstruction Type	13/A		Storm Grate/Utility Type	11/2
	Iotal Cost.	φ 3200.00		Obstruction Type	NI/A		Storm Grate/Otimity Type	N/A
					N/A			N/A
