Access Compliance Report Public Rights-of-Way (Curb Ramps)

Intersection ID: 51511Main Street: PEARL_PARK_WYCross Street: S_KINGS_DRLocation:NWADA ID: 773F29CE5E43Ramp Type: PerpInitial Pass/Fail: FailOverall Compliance: NoSeverity Score: 8.75

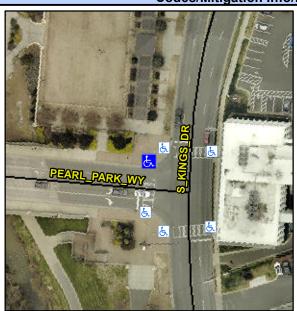
Field Measurements/Component Compliance						
Comp	liance Description	Data	Comp	liance Description	Data	
N/A	Ramp Length (in)	48.0	Yes	Ramp Slope (%)	6.7	
No	Ramp Width (in)	45.0	Yes	Ramp XSlope (%)	0.4	
N/A	Flare Type LT	N/A	N/A	Flare Type RT	N/A	
N/A	Flare Slope LT (%)	N/A	N/A	Flare Slope RT (%)	N/A	
N/A	Flare Traversable LT?	N/A	N/A	Flare Traversable RT?	N/A	
N/A	Landing Length (in)	N/A	N/A	DWS Provided?	N/A	
N/A	Landing Width (in)	N/A	N/A	DWS Contrast?	N/A	
N/A	Landing Slope (%)	N/A	N/A	DWS Length (in)	N/A	
N/A	Landing X Slope (%)	N/A	N/A	DWS Full Width?	N/A	
N/A	Landing Curb? (Y/N)	N/A	N/A	DWS Offset (in)	N/A	
N/A	Shared Landing?	N/A				
N/A	Gutter Ponding?	N/A	N/A	Gutter Slope (%)	N/A	
N/A	Gutter Lip Ht (in)	N/A	N/A	Gutter X Slope (%)	N/A	
N/A	Painted X Walk1?	Yes	N/A	Painted X Walk2?	N/A	
	X Walk 1 Direction	To S		X Walk 2 Direction	N/A	
N/A	X Walk 1 Width (in)	118.0	N/A	X Walk 2 Width (in)	N/A	
	X Walk 1 Slope (%)	2.7		X Walk 2 Slope (%)	N/A

X Walk 1 X Slope (%)	2.3		X Walk 2 X Slope (%)	N/A	
N/A	Ramp inside XWalk1?	Yes	N/A	Ramp inside XWalk2?	N/A	
	Road Slope (%)	N/A	N/A	Clear Space?	N/A	
	Road X Slope (%)	N/A	N/A	Clear Space to XWalk (in)	N/A	
N/A	Any Obstructions?	N/A	N/A	Storm Grate/Utility Hazard?	N/A	
	Obstruction Type			Storm Grate/Utility Type		
		N/A			N/A	
			Yes	Surface Condition? (G/P)	Good

ossible Solution			
Possible Solutions:	Comp	Compliance	
Remove & Replace Entire Ramp.	N/A	Ramp	
·	No	Ramp	
	N/A	Flare ⁻	
	N/A	Flare	
	N/A	Flare 7	
	N/A	Landin	
Surveyor Notes:	N/A	Landin	
N/A	N/A	Landin	
	N/A	Landin	
	N/A	Landin	
	N/A	Share	
PROW/ADA:	N/A	Gutter	
Not Found, R304.5.1	N/A	Gutter	
	N/A	Painte	
		X Wall	
	N/A	X Wall	
		X Wall	
		X Wall	
	N/A	Ramp	
		Road	
		Road 3
