Access Compliance Report

Public Rights-of-Way

(Curb Ramps)

| Intersection ID: 18726 | Main Street: TYVOLA_RD | Cross Street: OLD_PINEVILLE_RD | Location: NW |

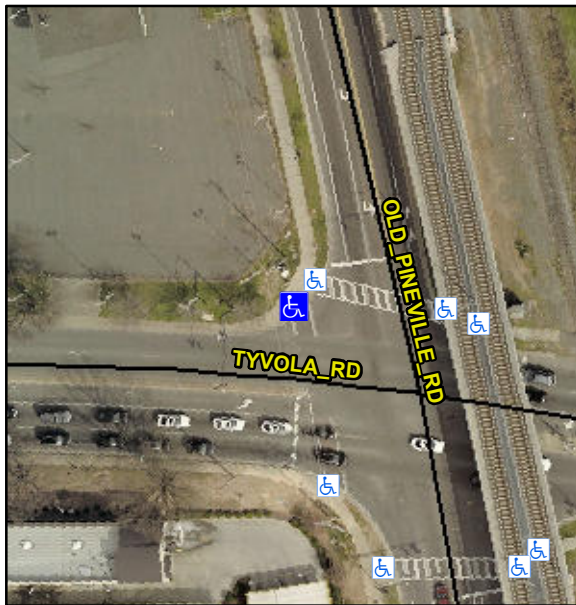
Not Found, R304.5.1, R304.2.2, R304.5.3

| Compliance | Description | Data | Compliance | Description | Data |
|---|---|---|---|---|---|
| N/A | Ramp Length (in) | 118.0 | No | Ramp Slope (%) | 8.6 |
| No | Ramp Width (in) | 47.0 | No | Ramp XSlope (%) | 4.1 |

Remove & Replace Entire Ramp.
