Access Compliance Report

Public Rights-of-Way

(Curb Ramps)

Intersection ID: 18767	Main Street: COOPER_DR	Cross Street: GLENHAM_DR	Location: SW
ADA ID: 774236296C8B	Ramp Type: Directional1	Initial Pass/Fail: Fail	Overall Compliance: No
Codes/Mitigation Info/Possible Solution		Field Measurements/Component Compliance

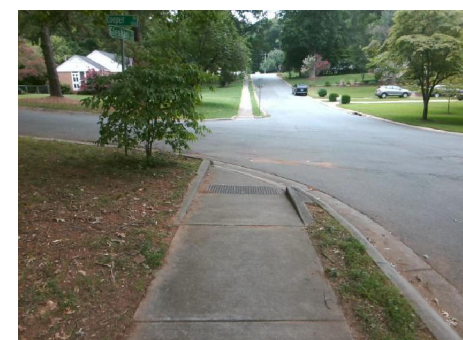
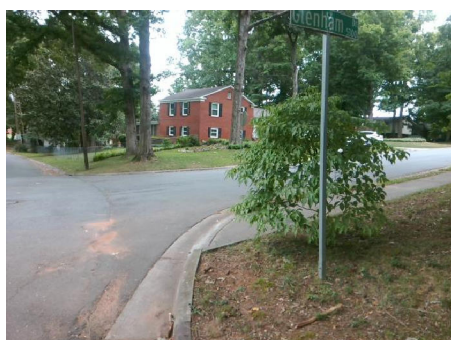
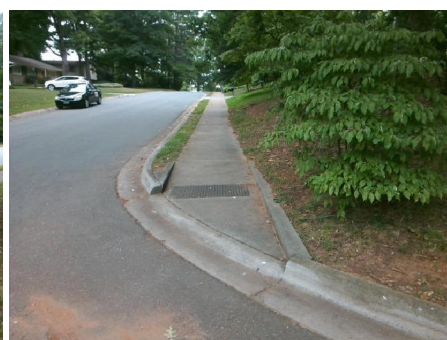
Compliance	Description	Data	Compliance	Description	Data
N/A	Ramp Length (in)	76.0	N/A	Grade Break?	N/A
Yes	Ramp Width (in)	59.0	N/A	Grade Break Slope (%)	0.0
No	Ramp Slope (%)	11.2	N/A	Grade Break XSlope (%)	0.0
No	Ramp XSlope (%)	4.2			
N/A	Flare Type LT	N/A	N/A	Flare Type RT	N/A
N/A	Flare Slope LT (%)	N/A	N/A	Flare Slope RT (%)	0.0
N/A	Flare Traversable LT?	N/A	N/A	Flare Traversable RT?	N/A
N/A	Landing Length (in)	0.0	N/A	DWS Provided?	N/A
N/A	Landing Width (in)	0.0	N/A	DWS Contrast?	N/A
N/A	Landing Slope (%)	0.0	N/A	DWS Length (in)	N/A
N/A	Landing X Slope (%)	0.0	N/A	DWS Full Width?	N/A
N/A	Landing Curb? (Y/N)	N/A	N/A	DWS Offset LT (in)	N/A
N/A	Shared Landing?	N/A	N/A	DWS Offset RT (in)	N/A
N/A	Gutter Ponding?	0.0	N/A	Gutter Slope (%)	N/A
N/A	Gutter Lip Ht (in)	0.0	N/A	Gutter X Slope (%)	N/A
N/A	Painted X Walk1?	No		Road Slope (%)	0.2
	X Walk 1 Direction	To N		Road X Slope (%)	1.2
	X Walk 1 Width (in)	N/A		Clear Space?	N/A

X Walk 1 Slope (%)	0.2	N/A	Clear Space to XWalk (in)	N/A
	X Walk 1 X Slope (%)	1.2	N/A	Storm Grate/Utility Hazard?	N/A
N/A	Ramp inside XWalk1?	N/A		Storm Grate/Utility Type	
N/A	Any Obstructions?	N/A			N/A
	Obstruction Type		Yes	Surface Condition? (G/P)	Good
			N/A	Curb Slope (%)	36.2

Remove & Replace Entire Ramp.
