# Access Compliance Report

## Public Rights-of-Way

### (Curb Ramps)

Intersection ID: 27680	Main Street: LANCASTER_HY	Cross Street: BALLANTYNE_COMMONS_PY	Location: NW
ADA ID: 774A905575A7	Ramp Type: Perp	Initial Pass/Fail: Fail	Overall Compliance: No
Severity Score: 8.75			
Codes/Mitigation Info/Possible Solution		Field Measurements/Component Compliance

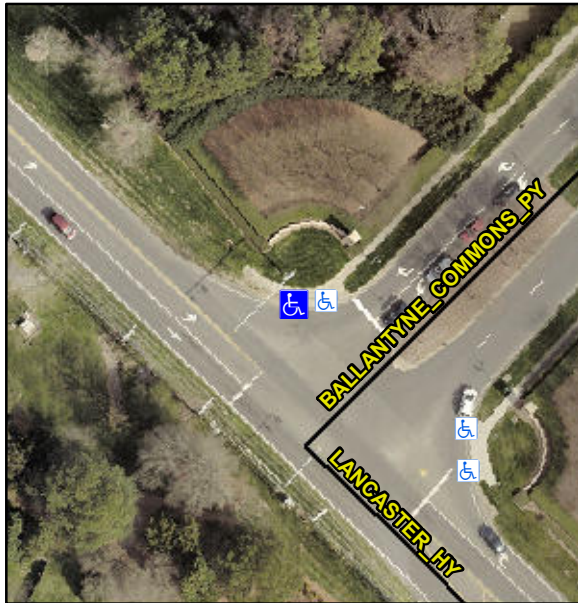
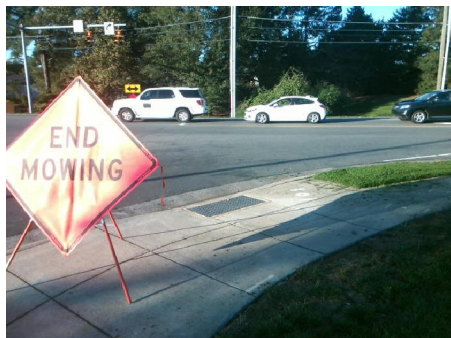
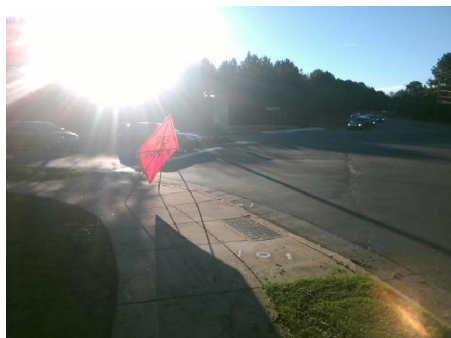
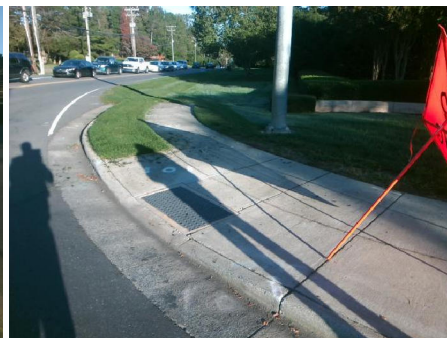
**Not Found, R304.5.1**

Compliance	Description	Data	Compliance	Description	Data
N/A	Ramp Length (in)	47.0	Yes	Ramp Slope (%)	6.3
No	Ramp Width (in)	46.0	Yes	Ramp XSlope (%)	0.6
N/A	Flare Type LT	N/A	N/A	Flare Type RT	N/A
N/A	Flare Slope LT (%)	N/A	N/A	Flare Slope RT (%)	N/A
N/A	Flare Traversable LT?	N/A	N/A	Flare Traversable RT?	N/A
N/A	Landing Length (in)	N/A	N/A	DWS Provided?	N/A
N/A	Landing Width (in)	N/A	N/A	DWS Contrast?	N/A
N/A	Landing Slope (%)	N/A	N/A	DWS Length (in)	N/A
N/A	Landing X Slope (%)	N/A	N/A	DWS Full Width?	N/A
N/A	Landing Curb? (Y/N)	N/A	N/A	DWS Offset (in)	N/A
N/A	Shared Landing?	N/A			
N/A	Gutter Ponding?	N/A	N/A	Gutter Slope (%)	N/A
N/A	Gutter Lip Ht (in)	N/A	N/A	Gutter X Slope (%)	N/A
N/A	Painted X Walk1?	No	N/A	Painted X Walk2?	N/A
	X Walk 1 Direction	To SW		X Walk 2 Direction	N/A
N/A	X Walk 1 Width (in)	N/A	N/A	X Walk 2 Width (in)	N/A
	X Walk 1 Slope (%)	5.2		X Walk 2 Slope (%)	N/A
	X Walk 1 X Slope (%)	1.0		X Walk 2 X Slope (%)	N/A

N/A	Ramp inside XWalk1?	N/A	N/A	Ramp inside XWalk2?	N/A
	Road Slope (%)	N/A	N/A	Clear Space?	N/A
	Road X Slope (%)	N/A	N/A	Clear Space to XWalk (in)	N/A
N/A	Any Obstructions?	N/A	N/A	Storm Grate/Utility Hazard?	N/A
	Obstruction Type			Storm Grate/Utility Type	
		N/A			N/A
			Yes	Surface Condition? (G/P)	Good

**Remove & Replace Entire Ramp.**
