# Access Compliance Report

## Public Rights-of-Way

### (Curb Ramps)

Intersection ID: 44943	Main Street: COLTART_CT	Cross Street: LARIMER_LN	Location:	E
ADA ID: 77605C60542B	Ramp Type: PerpDiag	Initial Pass/Fail: Fail	Overall Compliance: No	Severity Score: 42.5

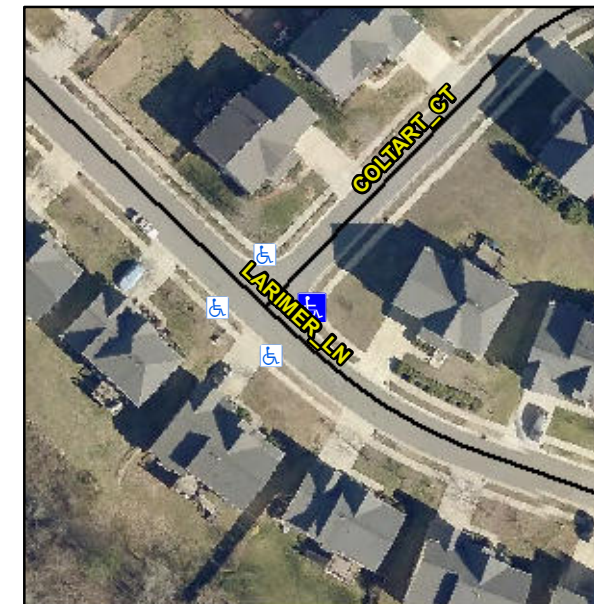
**Not Found, R304.5.1, R304.5.3**

Compliance	Description	Data	Compliance	Description	Data
N/A	Ramp Length (in)	49.0	Yes	Ramp Slope (%)	5.0
No	Ramp Width (in)	33.0	No	Ramp XSlope (%)	10.4
N/A	Flare Type LT	N/A	N/A	Flare Type RT	N/A
N/A	Flare Slope LT (%)	N/A	N/A	Flare Slope RT (%)	N/A
N/A	Flare Traversable LT?	N/A	N/A	Flare Traversable RT?	N/A
N/A	Landing Length (in)	N/A	N/A	DWS Provided?	N/A
N/A	Landing Width (in)	N/A	N/A	DWS Contrast?	N/A
N/A	Landing Slope (%)	N/A	N/A	DWS Length (in)	N/A
N/A	Landing X Slope (%)	N/A	N/A	DWS Full Width?	N/A
N/A	Landing Curb? (Y/N)	N/A	N/A	DWS Offset (in)	N/A
N/A	Shared Landing?	N/A			
N/A	Gutter Ponding?	N/A	N/A	Gutter Slope (%)	N/A
N/A	Gutter Lip Ht (in)	N/A	N/A	Gutter X Slope (%)	N/A
N/A	Painted X Walk1?	No	N/A	Painted X Walk2?	No
	X Walk 1 Direction	To NW		X Walk 2 Direction	To SW
N/A	X Walk 1 Width (in)	N/A	N/A	X Walk 2 Width (in)	N/A
	X Walk 1 Slope (%)	3.2		X Walk 2 Slope (%)	5.4
	X Walk 1 X Slope (%)	5.2		X Walk 2 X Slope (%)	4.9

N/A	Ramp inside XWalk1?	N/A	N/A	Ramp inside XWalk2?	N/A
	Road Slope (%)	8.2	N/A	Clear Space?	N/A
	Road X Slope (%)	2.6	N/A	Clear Space to XWalk (in)	N/A
N/A	Any Obstructions?	N/A	N/A	Storm Grate/Utility Hazard?	N/A
	Obstruction Type			Storm Grate/Utility Type	
		N/A			N/A
			Yes	Surface Condition? (G/P)	Good

**Remove & Replace Curb Ramp With Two New Directional Ramps or Equivalent.**
