Access Compliance Report

Public Rights-of-Way

(Curb Ramps)

Intersection ID: 45761	Main Street: SOLACE_CT	Cross Street: GRANDEUR_RD	Location: NW
ADA ID: 7767F3C289B0	Ramp Type: Perp	Initial Pass/Fail: Fail	Overall Compliance: No
Codes/Mitigation Info/Possible Solution			Severity Score: 25
			Field Measurements/Component Compliance

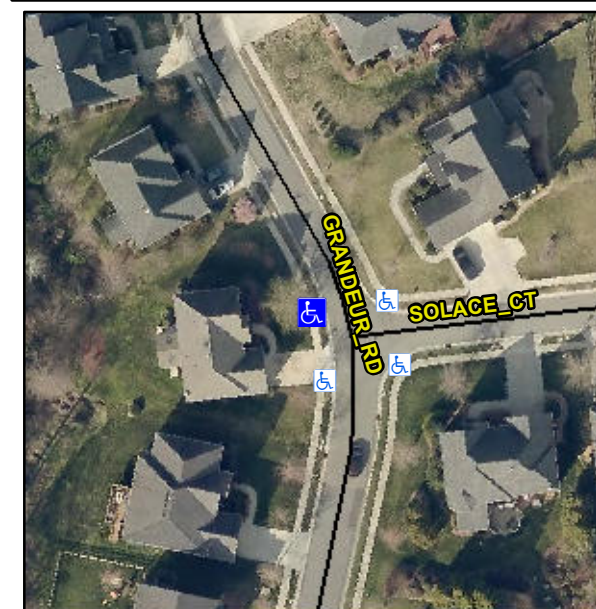
Not Found, R304.2.2, R304.5.3

Compliance	Description	Data	Compliance	Description	Data
N/A	Ramp Length (in)	47.0	No	Ramp Slope (%)	10.3
Yes	Ramp Width (in)	48.0	No	Ramp XSlope (%)	5.3
N/A	Flare Type LT	N/A	N/A	Flare Type RT	N/A
N/A	Flare Slope LT (%)	N/A	N/A	Flare Slope RT (%)	N/A
N/A	Flare Traversable LT?	N/A	N/A	Flare Traversable RT?	N/A
N/A	Landing Length (in)	N/A	N/A	DWS Provided?	N/A
N/A	Landing Width (in)	N/A	N/A	DWS Contrast?	N/A
N/A	Landing Slope (%)	N/A	N/A	DWS Length (in)	N/A
N/A	Landing X Slope (%)	N/A	N/A	DWS Full Width?	N/A
N/A	Landing Curb? (Y/N)	N/A	N/A	DWS Offset (in)	N/A
N/A	Shared Landing?	N/A			
N/A	Gutter Ponding?	N/A	N/A	Gutter Slope (%)	N/A
N/A	Gutter Lip Ht (in)	N/A	N/A	Gutter X Slope (%)	N/A
N/A	Painted X Walk1?	No	N/A	Painted X Walk2?	N/A
	X Walk 1 Direction	To E		X Walk 2 Direction	N/A
N/A	X Walk 1 Width (in)	N/A	N/A	X Walk 2 Width (in)	N/A
	X Walk 1 Slope (%)	6.6		X Walk 2 Slope (%)	N/A
	X Walk 1 X Slope (%)	4.9		X Walk 2 X Slope (%)	N/A

N/A	Ramp inside XWalk1?	N/A	N/A	Ramp inside XWalk2?	N/A
	Road Slope (%)	N/A	N/A	Clear Space?	N/A
	Road X Slope (%)	N/A	N/A	Clear Space to XWalk (in)	N/A
N/A	Any Obstructions?	N/A	N/A	Storm Grate/Utility Hazard?	N/A
	Obstruction Type			Storm Grate/Utility Type	
		N/A			N/A
			Yes	Surface Condition? (G/P)	Good

Possible Solutions:

Remove & Replace Entire Ramp.
