Access Compliance Report

Public Rights-of-Way

(Curb Ramps)

Intersection ID: 42743	Main Street: CRUTCHFIELD_PL	Cross Street: MACANTHRA_DR	Location:	NW
ADA ID: 776F7560B5A3	Ramp Type: PerpDiag	Initial Pass/Fail: Fail	Overall Compliance: No	Severity Score: 35
Codes/Mitigation Info/Possible Solution		Field Measurements/Component Compliance

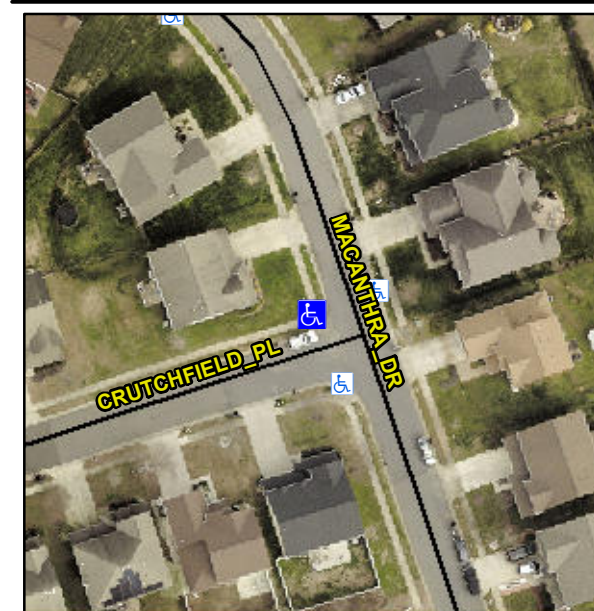
Not Found, R304.5.1, R304.2.2, R304.5.3

Compliance	Description	Data	Compliance	Description	Data
N/A	Ramp Length (in)	51.0	No	Ramp Slope (%)	16.1
No	Ramp Width (in)	38.0	No	Ramp XSlope (%)	2.9
N/A	Flare Type LT	N/A	N/A	Flare Type RT	N/A
N/A	Flare Slope LT (%)	N/A	N/A	Flare Slope RT (%)	N/A
N/A	Flare Traversable LT?	N/A	N/A	Flare Traversable RT?	N/A
N/A	Landing Length (in)	N/A	N/A	DWS Provided?	N/A
N/A	Landing Width (in)	N/A	N/A	DWS Contrast?	N/A
N/A	Landing Slope (%)	N/A	N/A	DWS Length (in)	N/A
N/A	Landing X Slope (%)	N/A	N/A	DWS Full Width?	N/A
N/A	Landing Curb? (Y/N)	N/A	N/A	DWS Offset (in)	N/A
N/A	Shared Landing?	N/A			
N/A	Gutter Ponding?	N/A	N/A	Gutter Slope (%)	N/A
N/A	Gutter Lip Ht (in)	N/A	N/A	Gutter X Slope (%)	N/A
N/A	Painted X Walk1?	No	N/A	Painted X Walk2?	No
	X Walk 1 Direction	To S		X Walk 2 Direction	To E
N/A	X Walk 1 Width (in)	N/A	N/A	X Walk 2 Width (in)	N/A
	X Walk 1 Slope (%)	1.5		X Walk 2 Slope (%)	0.7
	X Walk 1 X Slope (%)	0.5		X Walk 2 X Slope (%)	2.3

N/A	Ramp inside XWalk1?	N/A	N/A	Ramp inside XWalk2?	N/A
	Road Slope (%)	1.0	N/A	Clear Space?	N/A
	Road X Slope (%)	1.8	N/A	Clear Space to XWalk (in)	N/A
N/A	Any Obstructions?	N/A	N/A	Storm Grate/Utility Hazard?	N/A
	Obstruction Type			Storm Grate/Utility Type	
		N/A			N/A
			Yes	Surface Condition? (G/P)	Good

Remove & Replace Curb Ramp With Two New Directional Ramps or Equivalent.
