# Access Compliance Report

## Public Rights-of-Way

### (Curb Ramps)

Intersection ID: 13365	Main Street: N_SHARON_AMITY_RD	Cross Street: SUDBURY_RD	Location: SW
ADA ID: 77716EC9EB62	Ramp Type: Perp	Initial Pass/Fail: Fail	Overall Compliance: No
			Severity Score: 21.25

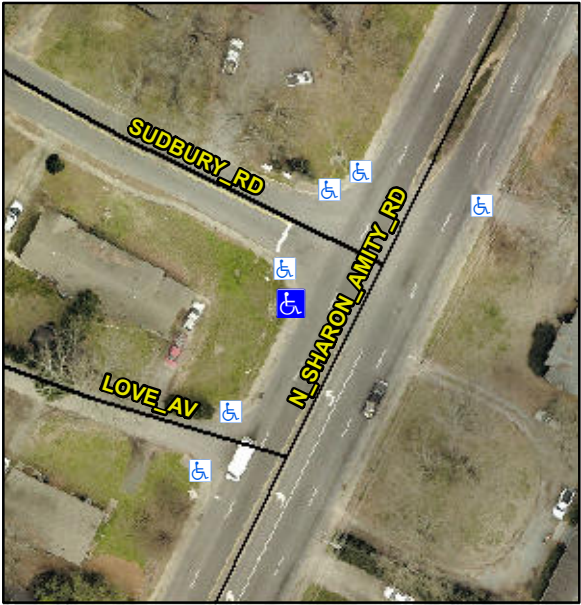
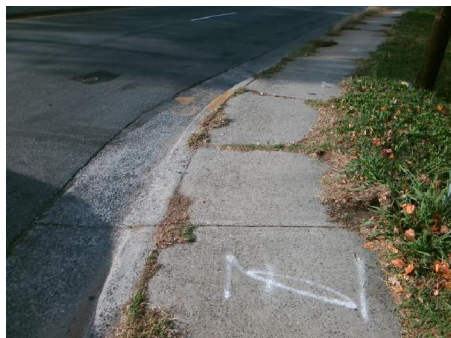
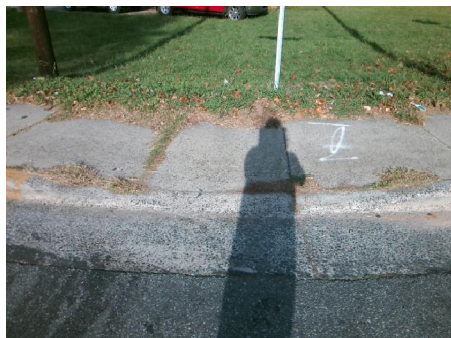
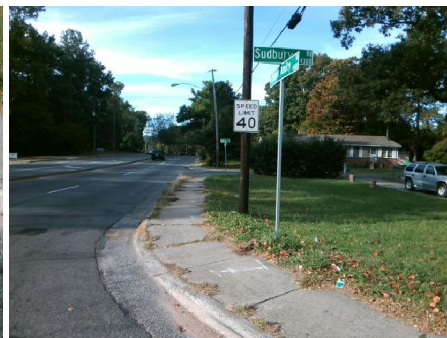
Compliance	Description	Data	Compliance	Description	Data
N/A	Ramp Length (in)	58.5	No	Ramp Slope (%)	9.4
No	Ramp Width (in)	38.0	Yes	Ramp XSlope (%)	0.3
N/A	Flare Type LT	N/A	N/A	Flare Type RT	N/A
N/A	Flare Slope LT (%)	N/A	N/A	Flare Slope RT (%)	N/A
N/A	Flare Traversable LT?	N/A	N/A	Flare Traversable RT?	N/A
N/A	Landing Length (in)	N/A	N/A	DWS Provided?	N/A
N/A	Landing Width (in)	N/A	N/A	DWS Contrast?	N/A
N/A	Landing Slope (%)	N/A	N/A	DWS Length (in)	N/A
N/A	Landing X Slope (%)	N/A	N/A	DWS Full Width?	N/A
N/A	Landing Curb? (Y/N)	N/A	N/A	DWS Offset (in)	N/A
N/A	Shared Landing?	N/A			
N/A	Gutter Ponding?	N/A	N/A	Gutter Slope (%)	N/A
N/A	Gutter Lip Ht (in)	N/A	N/A	Gutter X Slope (%)	N/A
N/A	Painted X Walk1?	No	N/A	Painted X Walk2?	N/A
	X Walk 1 Direction	To SE		X Walk 2 Direction	N/A
N/A	X Walk 1 Width (in)	N/A	N/A	X Walk 2 Width (in)	N/A
	X Walk 1 Slope (%)	3.7		X Walk 2 Slope (%)	N/A
	X Walk 1 X Slope (%)	1.7		X Walk 2 X Slope (%)	N/A

N/A	Ramp inside XWalk1?	N/A	N/A	Ramp inside XWalk2?	N/A
	Road Slope (%)	N/A	N/A	Clear Space?	N/A
	Road X Slope (%)	N/A	N/A	Clear Space to XWalk (in)	N/A
N/A	Any Obstructions?	N/A	N/A	Storm Grate/Utility Hazard?	N/A
	Obstruction Type			Storm Grate/Utility Type	
		N/A			N/A
			Yes	Surface Condition? (G/P)	Good

Possible Solutions:			
		Remove & Replace Entire Ramp.			
		Surveyor Notes:			
		N/A			
		PROW/ADA:			
		Not Found, R304.5.1, R304.2.2			
Street 1 Name	N SHARON AMITY RD				
Stop Condition-Street 2	None				
Street 2 Name	N/A				
Stop Condition-Street 1	N/A				
Total Cost:		\$ 1850.00
