Access Compliance Report

Public Rights-of-Way

(Curb Ramps)

Intersection ID: 17908	Main Street: CHENANGO_DR	Cross Street: IDLEWILD_RD	Location: SE
ADA ID: 7786B89EAAB9	Ramp Type: PerpDiag	Initial Pass/Fail: Fail	Overall Compliance: No
		Severity Score: 25

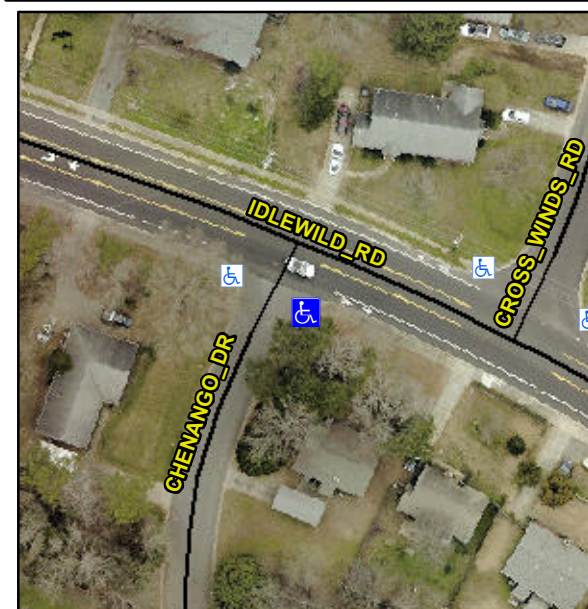
Not Found, R304.2.2

Compliance	Description	Data	Compliance	Description	Data
N/A	Ramp Length (in)	60.0	No	Ramp Slope (%)	12.9
Yes	Ramp Width (in)	48.0	Yes	Ramp XSlope (%)	0.2
N/A	Flare Type LT	N/A	N/A	Flare Type RT	N/A
N/A	Flare Slope LT (%)	N/A	N/A	Flare Slope RT (%)	N/A
N/A	Flare Traversable LT?	N/A	N/A	Flare Traversable RT?	N/A
N/A	Landing Length (in)	N/A	N/A	DWS Provided?	N/A
N/A	Landing Width (in)	N/A	N/A	DWS Contrast?	N/A
N/A	Landing Slope (%)	N/A	N/A	DWS Length (in)	N/A
N/A	Landing X Slope (%)	N/A	N/A	DWS Full Width?	N/A
N/A	Landing Curb? (Y/N)	N/A	N/A	DWS Offset (in)	N/A
N/A	Shared Landing?	N/A			
N/A	Gutter Ponding?	N/A	N/A	Gutter Slope (%)	N/A
N/A	Gutter Lip Ht (in)	N/A	N/A	Gutter X Slope (%)	N/A
N/A	Painted X Walk1?	No	N/A	Painted X Walk2?	No
	X Walk 1 Direction	To NE		X Walk 2 Direction	To NW
N/A	X Walk 1 Width (in)	N/A	N/A	X Walk 2 Width (in)	N/A
	X Walk 1 Slope (%)	4.0		X Walk 2 Slope (%)	3.5
	X Walk 1 X Slope (%)	2.2		X Walk 2 X Slope (%)	3.1

N/A	Ramp inside XWalk1?	N/A	N/A	Ramp inside XWalk2?	N/A
	Road Slope (%)	0.6	N/A	Clear Space?	N/A
	Road X Slope (%)	5.7	N/A	Clear Space to XWalk (in)	N/A
N/A	Any Obstructions?	N/A	N/A	Storm Grate/Utility Hazard?	N/A
	Obstruction Type			Storm Grate/Utility Type	
		N/A			N/A
			Yes	Surface Condition? (G/P)	Good

Remove & Replace Curb Ramp With Two New Directional Ramps or Equivalent.

Total Cost: \$ 3200.00
