# Access Compliance Report

## Public Rights-of-Way

### (Curb Ramps)

Intersection ID: 12411	Main Street: GREENLAND_AV	Cross Street: W_MOREHEAD_ST	Location: NW
ADA ID: 77885640A203	Ramp Type: PerpDiag	Initial Pass/Fail: Fail	Overall Compliance: No
Severity Score: 10			
Codes/Mitigation Info/Possible Solution		Field Measurements/Component Compliance

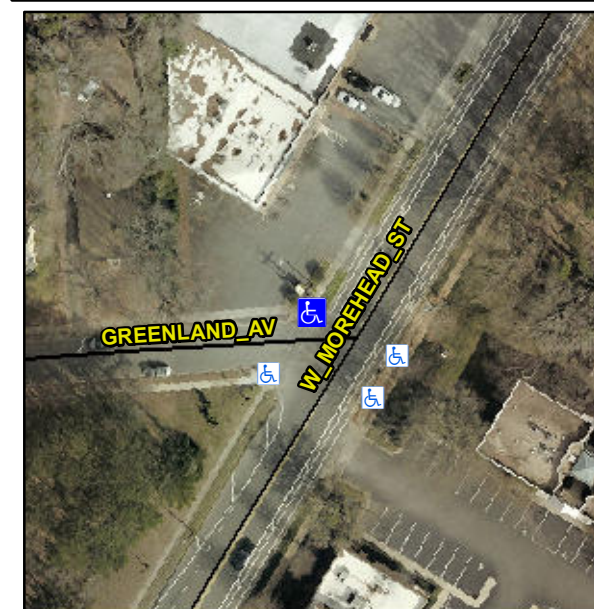
Compliance	Description	Data	Compliance	Description	Data
N/A	Ramp Length (in)	78.0	Yes	Ramp Slope (%)	5.0
No	Ramp Width (in)	47.0	No	Ramp XSlope (%)	2.9
N/A	Flare Type LT	N/A	N/A	Flare Type RT	N/A
N/A	Flare Slope LT (%)	N/A	N/A	Flare Slope RT (%)	N/A
N/A	Flare Traversable LT?	N/A	N/A	Flare Traversable RT?	N/A
N/A	Landing Length (in)	N/A	N/A	DWS Provided?	N/A
N/A	Landing Width (in)	N/A	N/A	DWS Contrast?	N/A
N/A	Landing Slope (%)	N/A	N/A	DWS Length (in)	N/A
N/A	Landing X Slope (%)	N/A	N/A	DWS Full Width?	N/A
N/A	Landing Curb? (Y/N)	N/A	N/A	DWS Offset (in)	N/A
N/A	Shared Landing?	N/A			
N/A	Gutter Ponding?	N/A	N/A	Gutter Slope (%)	N/A
N/A	Gutter Lip Ht (in)	N/A	N/A	Gutter X Slope (%)	N/A
N/A	Painted X Walk1?	No	N/A	Painted X Walk2?	No
	X Walk 1 Direction	To SW		X Walk 2 Direction	To SE
N/A	X Walk 1 Width (in)	N/A	N/A	X Walk 2 Width (in)	N/A
	X Walk 1 Slope (%)	2.8		X Walk 2 Slope (%)	2.6
	X Walk 1 X Slope (%)	0.1		X Walk 2 X Slope (%)	2.3

N/A	Ramp inside XWalk1?	N/A	N/A	Ramp inside XWalk2?	N/A
	Road Slope (%)	0.5	N/A	Clear Space?	N/A
	Road X Slope (%)	3.2	N/A	Clear Space to XWalk (in)	N/A
N/A	Any Obstructions?	N/A	N/A	Storm Grate/Utility Hazard?	N/A
	Obstruction Type			Storm Grate/Utility Type	
		N/A			N/A
			Yes	Surface Condition? (G/P)	Good

**Remove & Replace Curb Ramp With Two New Directional Ramps or Equivalent.**

**R304.5.1, R304.5.3**
