Access Compliance Report

Public Rights-of-Way

(Curb Ramps)

Intersection ID: 31585	Main Street: NAPTON_CT	Cross Street: PATTONSBURG_DR	Location: SW
ADA ID: 779488B0FD42	Ramp Type: PerpDiag	Initial Pass/Fail: Fail	Overall Compliance: No
Codes/Mitigation Info/Possible Solution		Field Measurements/Component Compliance	
Severity Score: 10

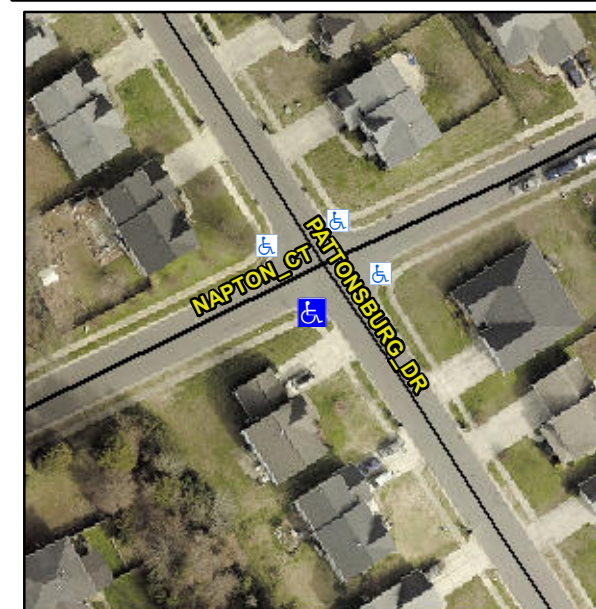
Not Found, R304.5.1, R304.5.3

Compliance	Description	Data	Compliance	Description	Data
N/A	Ramp Length (in)	41.0	Yes	Ramp Slope (%)	7.8
No	Ramp Width (in)	47.5	No	Ramp XSlope (%)	2.1
N/A	Flare Type LT	N/A	N/A	Flare Type RT	N/A
N/A	Flare Slope LT (%)	N/A	N/A	Flare Slope RT (%)	N/A
N/A	Flare Traversable LT?	N/A	N/A	Flare Traversable RT?	N/A
N/A	Landing Length (in)	N/A	N/A	DWS Provided?	N/A
N/A	Landing Width (in)	N/A	N/A	DWS Contrast?	N/A
N/A	Landing Slope (%)	N/A	N/A	DWS Length (in)	N/A
N/A	Landing X Slope (%)	N/A	N/A	DWS Full Width?	N/A
N/A	Landing Curb? (Y/N)	N/A	N/A	DWS Offset (in)	N/A
N/A	Shared Landing?	N/A			
N/A	Gutter Ponding?	N/A	N/A	Gutter Slope (%)	N/A
N/A	Gutter Lip Ht (in)	N/A	N/A	Gutter X Slope (%)	N/A
N/A	Painted X Walk1?	No	N/A	Painted X Walk2?	No
	X Walk 1 Direction	To E		X Walk 2 Direction	To N
N/A	X Walk 1 Width (in)	N/A	N/A	X Walk 2 Width (in)	N/A
	X Walk 1 Slope (%)	3.6		X Walk 2 Slope (%)	2.9
	X Walk 1 X Slope (%)	2.5		X Walk 2 X Slope (%)	1.3

N/A	Ramp inside XWalk1?	N/A	N/A	Ramp inside XWalk2?	N/A
	Road Slope (%)	1.3	N/A	Clear Space?	N/A
	Road X Slope (%)	1.5	N/A	Clear Space to XWalk (in)	N/A
N/A	Any Obstructions?	N/A	N/A	Storm Grate/Utility Hazard?	N/A
	Obstruction Type			Storm Grate/Utility Type	
		N/A			N/A
			Yes	Surface Condition? (G/P)	Good

Remove & Replace Curb Ramp With Two New Directional Ramps or Equivalent.
