# Access Compliance Report

## Public Rights-of-Way

### (Curb Ramps)

Intersection ID: 11325	Main Street: CARROWMORE_PL	Cross Street: THORNTON_RD	Location: NW
ADA ID: 779D32868AF8	Ramp Type: Perp	Initial Pass/Fail: Fail	Overall Compliance: No
		Severity Score: 8.75

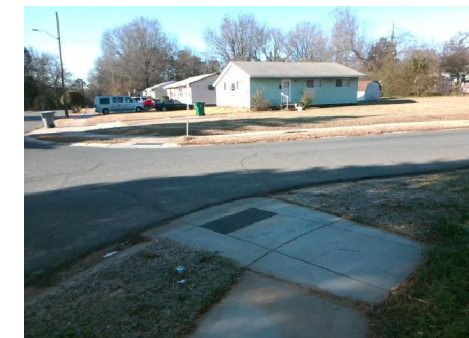
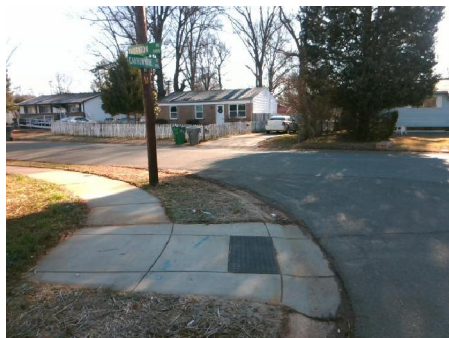
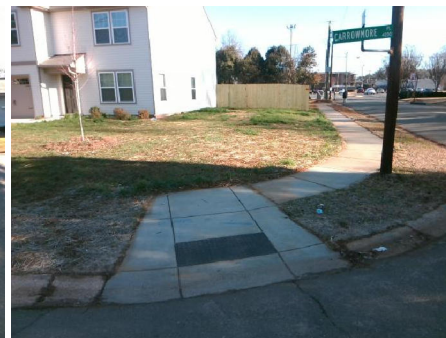
**Not Found, R304.5.1**

Compliance	Description	Data	Compliance	Description	Data
N/A	Ramp Length (in)	59.0	Yes	Ramp Slope (%)	5.5
No	Ramp Width (in)	47.0	Yes	Ramp XSlope (%)	0.5
N/A	Flare Type LT	N/A	N/A	Flare Type RT	N/A
N/A	Flare Slope LT (%)	N/A	N/A	Flare Slope RT (%)	N/A
N/A	Flare Traversable LT?	N/A	N/A	Flare Traversable RT?	N/A
N/A	Landing Length (in)	N/A	N/A	DWS Provided?	N/A
N/A	Landing Width (in)	N/A	N/A	DWS Contrast?	N/A
N/A	Landing Slope (%)	N/A	N/A	DWS Length (in)	N/A
N/A	Landing X Slope (%)	N/A	N/A	DWS Full Width?	N/A
N/A	Landing Curb? (Y/N)	N/A	N/A	DWS Offset (in)	N/A
N/A	Shared Landing?	N/A			
N/A	Gutter Ponding?	N/A	N/A	Gutter Slope (%)	N/A
N/A	Gutter Lip Ht (in)	N/A	N/A	Gutter X Slope (%)	N/A
N/A	Painted X Walk1?	No	N/A	Painted X Walk2?	N/A
	X Walk 1 Direction	To SW		X Walk 2 Direction	N/A
N/A	X Walk 1 Width (in)	N/A	N/A	X Walk 2 Width (in)	N/A
	X Walk 1 Slope (%)	2.7		X Walk 2 Slope (%)	N/A
	X Walk 1 X Slope (%)	0.7		X Walk 2 X Slope (%)	N/A

N/A	Ramp inside XWalk1?	N/A	N/A	Ramp inside XWalk2?	N/A
	Road Slope (%)	N/A	N/A	Clear Space?	N/A
	Road X Slope (%)	N/A	N/A	Clear Space to XWalk (in)	N/A
N/A	Any Obstructions?	N/A	N/A	Storm Grate/Utility Hazard?	N/A
	Obstruction Type			Storm Grate/Utility Type	
		N/A			N/A
			Yes	Surface Condition? (G/P)	Good

**Remove & Replace Entire Ramp.**

Total Cost: \$ 1850.00
