# Access Compliance Report

## Public Rights-of-Way (Curb Ramps)

Intersection ID: 28325	Main Street: BRIDGEHAMPTON CLUB_DR	Cross Street: MILLSFORD_CT	Location: SE
ADA ID: 779D8131FFB4	Ramp Type: Directional1	Initial Pass/Fail: Fail	Overall Compliance: No
Severity Score: 12.5			
Codes/Mitigation Info/Possible Solution		Field Measurements/Component Compliance

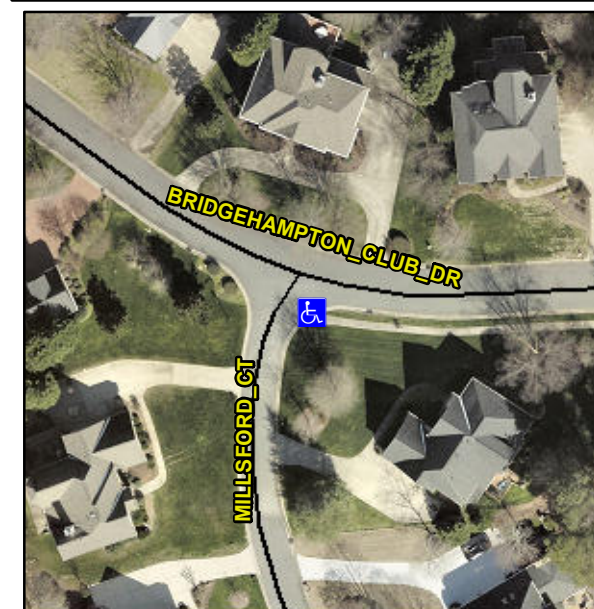
Compliance	Description	Data	Compliance	Description	Data
N/A	Ramp Length (in)	168.0	N/A	Grade Break?	N/A
Yes	Ramp Width (in)	48.0	N/A	Grade Break Slope (%)	0.0
No	Ramp Slope (%)	11.9	N/A	Grade Break XSlope (%)	0.0
Yes	Ramp XSlope (%)	0.1			
N/A	Flare Type LT	N/A	N/A	Flare Type RT	N/A
N/A	Flare Slope LT (%)	N/A	N/A	Flare Slope RT (%)	0.0
N/A	Flare Traversable LT?	N/A	N/A	Flare Traversable RT?	N/A
N/A	Landing Length (in)	0.0	N/A	DWS Provided?	N/A
N/A	Landing Width (in)	0.0	N/A	DWS Contrast?	N/A
N/A	Landing Slope (%)	0.0	N/A	DWS Length (in)	N/A
N/A	Landing X Slope (%)	0.0	N/A	DWS Full Width?	N/A
N/A	Landing Curb? (Y/N)	N/A	N/A	DWS Offset LT (in)	N/A
N/A	Shared Landing?	N/A	N/A	DWS Offset RT (in)	N/A
N/A	Gutter Ponding?	0.0	N/A	Gutter Slope (%)	N/A
N/A	Gutter Lip Ht (in)	0.0	N/A	Gutter X Slope (%)	N/A
N/A	Painted X Walk1?	No		Road Slope (%)	N/A
	X Walk 1 Direction	To W		Road X Slope (%)	N/A
	X Walk 1 Width (in)	N/A		Clear Space?	N/A

X Walk 1 Slope (%)	N/A	N/A	Clear Space to XWalk (in)	N/A
	X Walk 1 X Slope (%)	N/A	N/A	Storm Grate/Utility Hazard?	N/A
N/A	Ramp inside XWalk1?	N/A		Storm Grate/Utility Type	
N/A	Any Obstructions?	N/A			N/A
	Obstruction Type		Yes	Surface Condition? (G/P)	Good
			N/A	Curb Slope (%)	19.0

**Remove & Replace Entire Ramp.**
