Access Compliance Report

Public Rights-of-Way

(Curb Ramps)

Intersection ID: 10917	Main Street: E_25TH_ST	Cross Street: N_DAVIDSON_ST	Location: W
ADA ID: 779F398139DD	Ramp Type: Directional1	Initial Pass/Fail: Fail	Overall Compliance: No
			Severity Score: 46.25

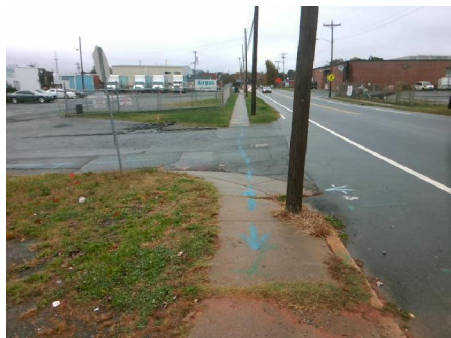
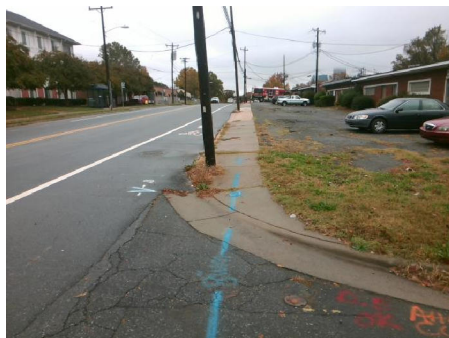
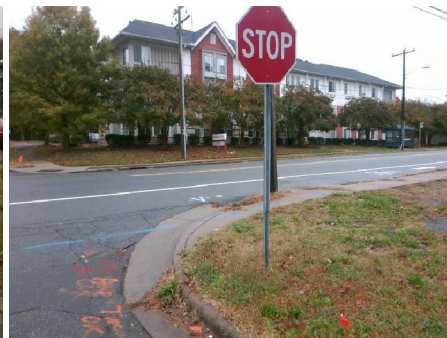
Compliance	Description	Data	Compliance	Description	Data
N/A	Ramp Length (in)	105.0	N/A	Grade Break?	N/A
No	Ramp Width (in)	40.0	N/A	Grade Break Slope (%)	0.0
No	Ramp Slope (%)	10.4	N/A	Grade Break XSlope (%)	0.0
No	Ramp XSlope (%)	7.9			
N/A	Flare Type LT	N/A	N/A	Flare Type RT	N/A
N/A	Flare Slope LT (%)	N/A	N/A	Flare Slope RT (%)	0.0
N/A	Flare Traversable LT?	N/A	N/A	Flare Traversable RT?	N/A
N/A	Landing Length (in)	0.0	N/A	DWS Provided?	N/A
N/A	Landing Width (in)	0.0	N/A	DWS Contrast?	N/A
N/A	Landing Slope (%)	0.0	N/A	DWS Length (in)	N/A
N/A	Landing X Slope (%)	0.0	N/A	DWS Full Width?	N/A
N/A	Landing Curb? (Y/N)	N/A	N/A	DWS Offset LT (in)	N/A
N/A	Shared Landing?	N/A	N/A	DWS Offset RT (in)	N/A
N/A	Gutter Ponding?	0.0	N/A	Gutter Slope (%)	N/A
N/A	Gutter Lip Ht (in)	0.0	N/A	Gutter X Slope (%)	N/A
N/A	Painted X Walk1?	No		Road Slope (%)	1.4
	X Walk 1 Direction	To NE		Road X Slope (%)	6.4
	X Walk 1 Width (in)	N/A		Clear Space?	N/A

X Walk 1 Slope (%)	1.4	N/A	Clear Space to XWalk (in)	N/A
	X Walk 1 X Slope (%)	6.4	N/A	Storm Grate/Utility Hazard?	N/A
N/A	Ramp inside XWalk1?	N/A		Storm Grate/Utility Type	
N/A	Any Obstructions?	N/A			N/A
	Obstruction Type		Yes	Surface Condition? (G/P)	Good
			N/A	Curb Slope (%)	18.9

Remove & Replace Entire Ramp.
