# Access Compliance Report

## Public Rights-of-Way

### (Curb Ramps)

Intersection ID: 12779	Main Street: E_TRADE_ST	Cross Street: S_DAVIDSON_ST	Location: W
ADA ID: 77A850DB9D6F	Ramp Type: Perp	Initial Pass/Fail: Fail	Overall Compliance: No
Codes/Mitigation Info/Possible Solution		Field Measurements/Component Compliance

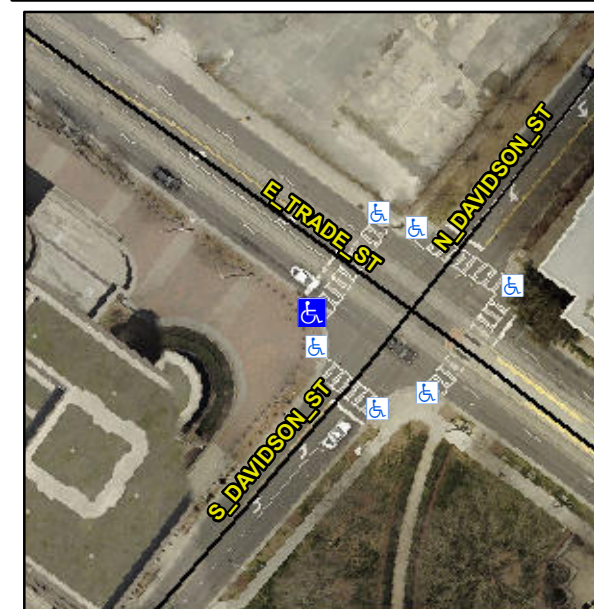
**Not Found, R304.2.2, R304.5.3**

Compliance	Description	Data	Compliance	Description	Data
N/A	Ramp Length (in)	72.0	No	Ramp Slope (%)	11.2
Yes	Ramp Width (in)	60.0	No	Ramp XSlope (%)	2.6
N/A	Flare Type LT	N/A	N/A	Flare Type RT	N/A
N/A	Flare Slope LT (%)	N/A	N/A	Flare Slope RT (%)	N/A
N/A	Flare Traversable LT?	N/A	N/A	Flare Traversable RT?	N/A
N/A	Landing Length (in)	N/A	N/A	DWS Provided?	N/A
N/A	Landing Width (in)	N/A	N/A	DWS Contrast?	N/A
N/A	Landing Slope (%)	N/A	N/A	DWS Length (in)	N/A
N/A	Landing X Slope (%)	N/A	N/A	DWS Full Width?	N/A
N/A	Landing Curb? (Y/N)	N/A	N/A	DWS Offset (in)	N/A
N/A	Shared Landing?	N/A			
N/A	Gutter Ponding?	N/A	N/A	Gutter Slope (%)	N/A
N/A	Gutter Lip Ht (in)	N/A	N/A	Gutter X Slope (%)	N/A
N/A	Painted X Walk1?	Yes	N/A	Painted X Walk2?	N/A
	X Walk 1 Direction	To NE		X Walk 2 Direction	N/A
N/A	X Walk 1 Width (in)	110.0	N/A	X Walk 2 Width (in)	N/A
	X Walk 1 Slope (%)	5.2		X Walk 2 Slope (%)	N/A
	X Walk 1 X Slope (%)	0.9		X Walk 2 X Slope (%)	N/A

N/A	Ramp inside XWalk1?	Yes	N/A	Ramp inside XWalk2?	N/A
	Road Slope (%)	N/A	N/A	Clear Space?	N/A
	Road X Slope (%)	N/A	N/A	Clear Space to XWalk (in)	N/A
N/A	Any Obstructions?	N/A	N/A	Storm Grate/Utility Hazard?	N/A
	Obstruction Type			Storm Grate/Utility Type	
		N/A			N/A
		Yes		Surface Condition? (G/P)	Good

Possible Solutions:

**Remove & Replace Entire Ramp.**
