Intersection ID: 6963	Main Street: CRAWFORD_DR	Cross Street: MERRILL_PL	Location:	SE
ADA ID: 77AC9676E104	Ramp Type: PerpDiag	Initial Pass/Fail: Fail	Overall Compliance: No	Severity Score: 33.75

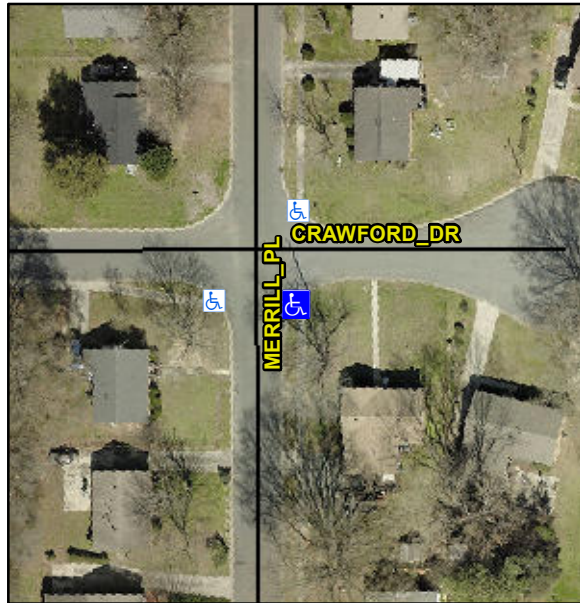
Not Found, R304.5.1, R304.2.2

Compliance	Description	Data	Compliance	Description	Data
N/A	Ramp Length (in)	26.0	No	Ramp Slope (%)	12.1
No	Ramp Width (in)	43.0	Yes	Ramp XSlope (%)	2.0
N/A	Flare Type LT	N/A	N/A	Flare Type RT	N/A
N/A	Flare Slope LT (%)	N/A	N/A	Flare Slope RT (%)	N/A
N/A	Flare Traversable LT?	N/A	N/A	Flare Traversable RT?	N/A
N/A	Landing Length (in)	N/A	N/A	DWS Provided?	N/A
N/A	Landing Width (in)	N/A	N/A	DWS Contrast?	N/A
N/A	Landing Slope (%)	N/A	N/A	DWS Length (in)	N/A
N/A	Landing X Slope (%)	N/A	N/A	DWS Full Width?	N/A
N/A	Landing Curb? (Y/N)	N/A	N/A	DWS Offset (in)	N/A
N/A	Shared Landing?	N/A			
N/A	Gutter Ponding?	N/A	N/A	Gutter Slope (%)	N/A
N/A	Gutter Lip Ht (in)	N/A	N/A	Gutter X Slope (%)	N/A
N/A	Painted X Walk1?	No	N/A	Painted X Walk2?	No
	X Walk 1 Direction	To N		X Walk 2 Direction	To W
N/A	X Walk 1 Width (in)	N/A	N/A	X Walk 2 Width (in)	N/A
	X Walk 1 Slope (%)	1.5		X Walk 2 Slope (%)	5.3
	X Walk 1 X Slope (%)	3.6		X Walk 2 X Slope (%)	0.9

N/A	Ramp inside XWalk1?	N/A	N/A	Ramp inside XWalk2?	N/A
	Road Slope (%)	1.8	N/A	Clear Space?	N/A
	Road X Slope (%)	8.0	N/A	Clear Space to XWalk (in)	N/A
N/A	Any Obstructions?	N/A	N/A	Storm Grate/Utility Hazard?	N/A
	Obstruction Type			Storm Grate/Utility Type	
		N/A			N/A
			Yes	Surface Condition? (G/P)	Good

Possible Solutions:

Remove & Replace Curb Ramp With Two New Directional Ramps or Equivalent.
