## **Access Compliance Report Public Rights-of-Way** (Curb Ramps)

Intersection ID: 10011804 Main Street: MASONIC DR Cross Street: N/A Location: Ε Initial Pass/Fail: Fail **Overall Compliance: No Severity Score:** 10 ADA ID: 77B272A20680 Ramp Type: Combination1

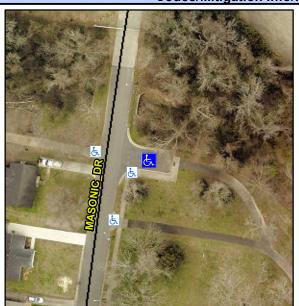
Possible Solutions: Compliance Description N/A Remove & Replace Entire Ramp. Yes Yes Yes N/A Yes Surveyor Notes: N/A LT RP < 5% N/A N/A N/A N/A PROW/ADA: N/A Not Found, R304.5.1, R304.5.3 N/A N/A N/A N/A N/A N/A
