# Access Compliance Report

## Public Rights-of-Way

### (Curb Ramps)

Intersection ID: 8650	Main Street: GARNETTE_PL	Cross Street: ST_MARK_ST	Location: SE
ADA ID: 77B508F71BFC	Ramp Type: Perp	Initial Pass/Fail: Fail	Overall Compliance: No Severity Score: 21.25

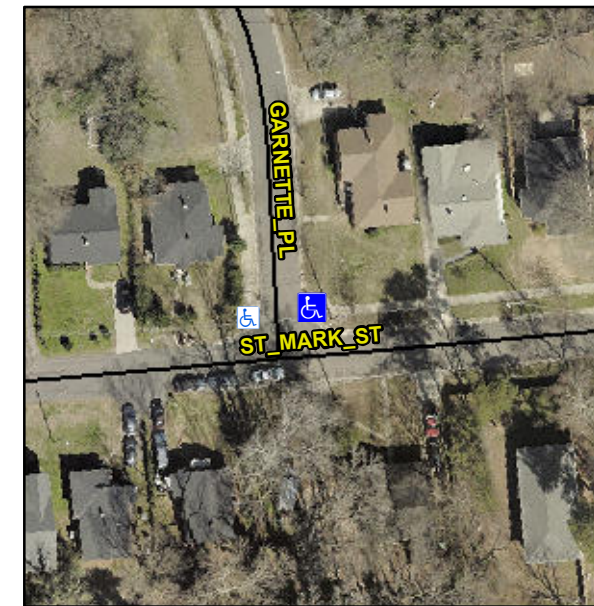
**Not Found, R304.5.1, R304.2.2**

Compliance	Description	Data	Compliance	Description	Data
N/A	Ramp Length (in)	73.0	No	Ramp Slope (%)	8.7
No	Ramp Width (in)	47.5	Yes	Ramp XSlope (%)	1.4
N/A	Flare Type LT	N/A	N/A	Flare Type RT	N/A
N/A	Flare Slope LT (%)	N/A	N/A	Flare Slope RT (%)	N/A
N/A	Flare Traversable LT?	N/A	N/A	Flare Traversable RT?	N/A
N/A	Landing Length (in)	N/A	N/A	DWS Provided?	N/A
N/A	Landing Width (in)	N/A	N/A	DWS Contrast?	N/A
N/A	Landing Slope (%)	N/A	N/A	DWS Length (in)	N/A
N/A	Landing X Slope (%)	N/A	N/A	DWS Full Width?	N/A
N/A	Landing Curb? (Y/N)	N/A	N/A	DWS Offset (in)	N/A
N/A	Shared Landing?	N/A			
N/A	Gutter Ponding?	N/A	N/A	Gutter Slope (%)	N/A
N/A	Gutter Lip Ht (in)	N/A	N/A	Gutter X Slope (%)	N/A
N/A	Painted X Walk1?	No	N/A	Painted X Walk2?	N/A
	X Walk 1 Direction	To W		X Walk 2 Direction	N/A
N/A	X Walk 1 Width (in)	N/A	N/A	X Walk 2 Width (in)	N/A
	X Walk 1 Slope (%)	4.3		X Walk 2 Slope (%)	N/A
	X Walk 1 X Slope (%)	1.6		X Walk 2 X Slope (%)	N/A

N/A	Ramp inside XWalk1?	N/A	N/A	Ramp inside XWalk2?	N/A
	Road Slope (%)	N/A	N/A	Clear Space?	N/A
	Road X Slope (%)	N/A	N/A	Clear Space to XWalk (in)	N/A
N/A	Any Obstructions?	N/A	N/A	Storm Grate/Utility Hazard?	N/A
	Obstruction Type			Storm Grate/Utility Type	
		N/A			N/A
			Yes	Surface Condition? (G/P)	Good

**Remove & Replace Entire Ramp.**

Total Cost: \$ 1850.00
