Access Compliance Report

Public Rights-of-Way

(Curb Ramps)

Intersection ID: 14864	Main Street: E_TREMONT_AV	Cross Street: LENNOX_AV	Location:	N
ADA ID: 77BA74BE58D8	Ramp Type: Directional1	Initial Pass/Fail: Fail	Overall Compliance: No	Severity Score: 10

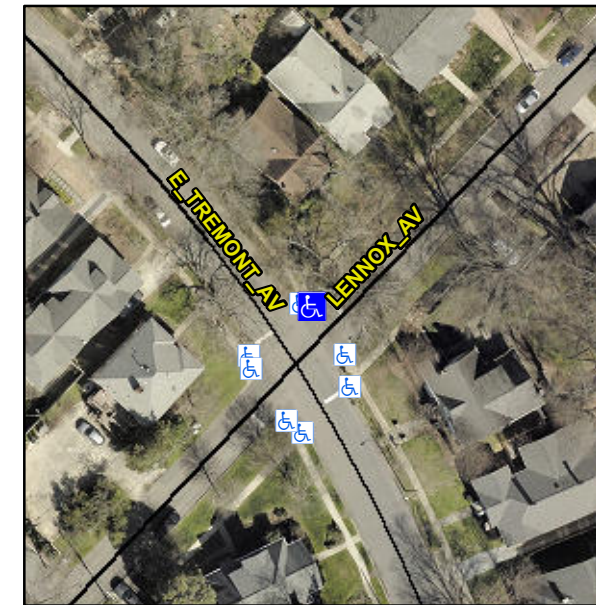
Compliance	Description	Data	Compliance	Description	Data
N/A	Ramp Length (in)	99.0	N/A	Grade Break?	N/A
No	Ramp Width (in)	46.0	N/A	Grade Break Slope (%)	0.0
Yes	Ramp Slope (%)	5.2	N/A	Grade Break XSlope (%)	0.0
No	Ramp XSlope (%)	3.6			
N/A	Flare Type LT	N/A	N/A	Flare Type RT	N/A
N/A	Flare Slope LT (%)	N/A	N/A	Flare Slope RT (%)	0.0
N/A	Flare Traversable LT?	N/A	N/A	Flare Traversable RT?	N/A
N/A	Landing Length (in)	0.0	N/A	DWS Provided?	N/A
N/A	Landing Width (in)	0.0	N/A	DWS Contrast?	N/A
N/A	Landing Slope (%)	0.0	N/A	DWS Length (in)	N/A
N/A	Landing X Slope (%)	0.0	N/A	DWS Full Width?	N/A
N/A	Landing Curb? (Y/N)	N/A	N/A	DWS Offset LT (in)	N/A
N/A	Shared Landing?	N/A	N/A	DWS Offset RT (in)	N/A
N/A	Gutter Ponding?	0.0	N/A	Gutter Slope (%)	N/A
N/A	Gutter Lip Ht (in)	2.0	N/A	Gutter X Slope (%)	N/A
N/A	Painted X Walk1?	No		Road Slope (%)	1.6
	X Walk 1 Direction	To SE		Road X Slope (%)	1.0
	X Walk 1 Width (in)	N/A		Clear Space?	N/A

X Walk 1 Slope (%)	1.6	N/A	Clear Space to XWalk (in)	N/A
	X Walk 1 X Slope (%)	1.0	N/A	Storm Grate/Utility Hazard?	N/A
N/A	Ramp inside XWalk1?	N/A		Storm Grate/Utility Type	
N/A	Any Obstructions?	N/A			N/A
	Obstruction Type		Yes	Surface Condition? (G/P)	Good
			N/A	Curb Slope (%)	1.1

Remove & Replace Entire Ramp.

R304.5.1, R304.5.3
