Access Compliance Report

Public Rights-of-Way

(Curb Ramps)

Intersection ID: 9447	Main Street: ATANDO_AV	Cross Street: N_TRYON_ST	Location: NE
ADA ID: 77BC05E87D53	Ramp Type: Perp	Initial Pass/Fail: Fail	Overall Compliance: No
		Severity Score: 8.75

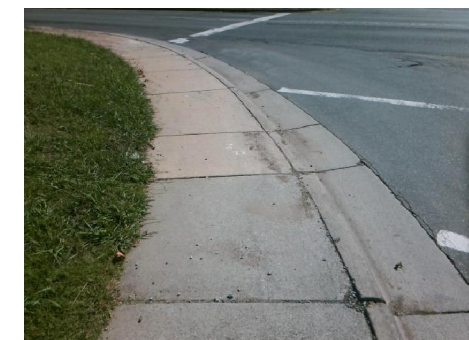
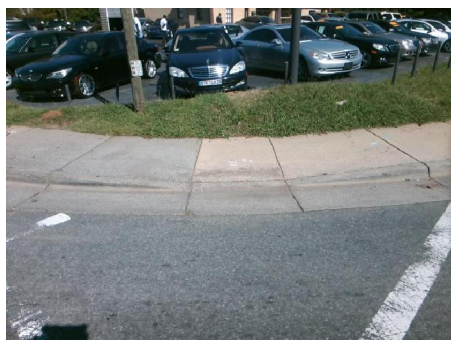
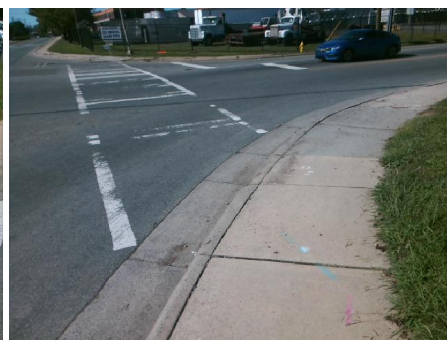
Not Found, R304.5.1

Compliance	Description	Data	Compliance	Description	Data
N/A	Ramp Length (in)	60.0	Yes	Ramp Slope (%)	7.3
No	Ramp Width (in)	41.0	Yes	Ramp XSlope (%)	0.6
N/A	Flare Type LT	N/A	N/A	Flare Type RT	N/A
N/A	Flare Slope LT (%)	N/A	N/A	Flare Slope RT (%)	N/A
N/A	Flare Traversable LT?	N/A	N/A	Flare Traversable RT?	N/A
N/A	Landing Length (in)	N/A	N/A	DWS Provided?	N/A
N/A	Landing Width (in)	N/A	N/A	DWS Contrast?	N/A
N/A	Landing Slope (%)	N/A	N/A	DWS Length (in)	N/A
N/A	Landing X Slope (%)	N/A	N/A	DWS Full Width?	N/A
N/A	Landing Curb? (Y/N)	N/A	N/A	DWS Offset (in)	N/A
N/A	Shared Landing?	N/A			
N/A	Gutter Ponding?	N/A	N/A	Gutter Slope (%)	N/A
N/A	Gutter Lip Ht (in)	0.5	N/A	Gutter X Slope (%)	N/A
N/A	Painted X Walk1?	Yes	N/A	Painted X Walk2?	N/A
	X Walk 1 Direction	To SW		X Walk 2 Direction	N/A
N/A	X Walk 1 Width (in)	111.0	N/A	X Walk 2 Width (in)	N/A
	X Walk 1 Slope (%)	3.1		X Walk 2 Slope (%)	N/A
	X Walk 1 X Slope (%)	3.4		X Walk 2 X Slope (%)	N/A

N/A	Ramp inside XWalk1?	Yes	N/A	Ramp inside XWalk2?	N/A
	Road Slope (%)	N/A	N/A	Clear Space?	N/A
	Road X Slope (%)	N/A	N/A	Clear Space to XWalk (in)	N/A
N/A	Any Obstructions?	N/A	N/A	Storm Grate/Utility Hazard?	N/A
	Obstruction Type			Storm Grate/Utility Type	
		N/A			N/A
			Yes	Surface Condition? (G/P)	Good

Possible Solutions:

Remove & Replace Entire Ramp.
