Access Compliance Report

Public Rights-of-Way

(Curb Ramps)

Intersection ID: 49382	Main Street: SOUTH_DEVON_ST	Cross Street: ROCKY_RIVER_RD	Location: SE
ADA ID: 77C31D1EC4D1	Ramp Type: Perp	Initial Pass/Fail: Fail	Overall Compliance: No
		Severity Score: 12.5

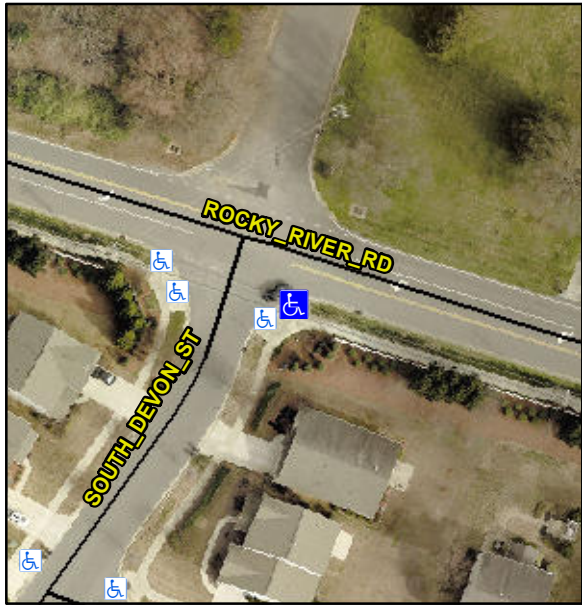
Possible Solutions:		Compliance	Description	Data	Compliance	Description	Data
	Remove & Replace Entire Ramp.		N/A	Ramp Length (in)	94.5	No	Ramp Slope (%)	8.8
			Yes	Ramp Width (in)	48.0	Yes	Ramp XSlope (%)	0.6
			N/A	Flare Type LT	N/A	N/A	Flare Type RT	N/A
			N/A	Flare Slope LT (%)	N/A	N/A	Flare Slope RT (%)	N/A
			N/A	Flare Traversable LT?	N/A	N/A	Flare Traversable RT?	N/A
			N/A	Landing Length (in)	N/A	N/A	DWS Provided?	N/A
			N/A	Landing Width (in)	N/A	N/A	DWS Contrast?	N/A
			N/A	Landing Slope (%)	N/A	N/A	DWS Length (in)	N/A
			N/A	Landing X Slope (%)	N/A	N/A	DWS Full Width?	N/A
<p>Surveyor Notes:</p> <p>N/A</p> <p>PROW/ADA:</p> <p>Not Found, R304.2.2</p>			N/A	Landing Curb? (Y/N)	N/A	N/A	DWS Offset (in)	N/A
			N/A	Shared Landing?	N/A			
			N/A	Gutter Ponding?	N/A	N/A	Gutter Slope (%)	N/A
			N/A	Gutter Lip Ht (in)	N/A	N/A	Gutter X Slope (%)	N/A

N/A	Painted X Walk1?	No	N/A	Painted X Walk2?	N/A
				X Walk 1 Direction	To NE		X Walk 2 Direction	N/A
			N/A	X Walk 1 Width (in)	N/A	N/A	X Walk 2 Width (in)	N/A
				X Walk 1 Slope (%)	1.0		X Walk 2 Slope (%)	N/A
				X Walk 1 X Slope (%)	0.4		X Walk 2 X Slope (%)	N/A
			N/A	Ramp inside XWalk1?	N/A	N/A	Ramp inside XWalk2?	N/A
			Road Slope (%)	0.4	N/A	Clear Space?	N/A	
			Road X Slope (%)	1.0	N/A	Clear Space to XWalk (in)	N/A	
		N/A	Any Obstructions?	N/A	N/A	Storm Grate/Utility Hazard?	N/A	
			Obstruction Type			Storm Grate/Utility Type		
					N/A			N/A
						Yes	Surface Condition? (G/P)	Good
