Access Compliance Report

Public Rights-of-Way

(Curb Ramps)

Intersection ID: 50272	Main Street: SOUTH_BV	Cross Street: WHITTON_ST	Location: NE
ADA ID: 77C8F2C490DD	Ramp Type: Perp	Initial Pass/Fail: Fail	Overall Compliance: No
Severity Score: 22.5			
Codes/Mitigation Info/Possible Solution		Field Measurements/Component Compliance

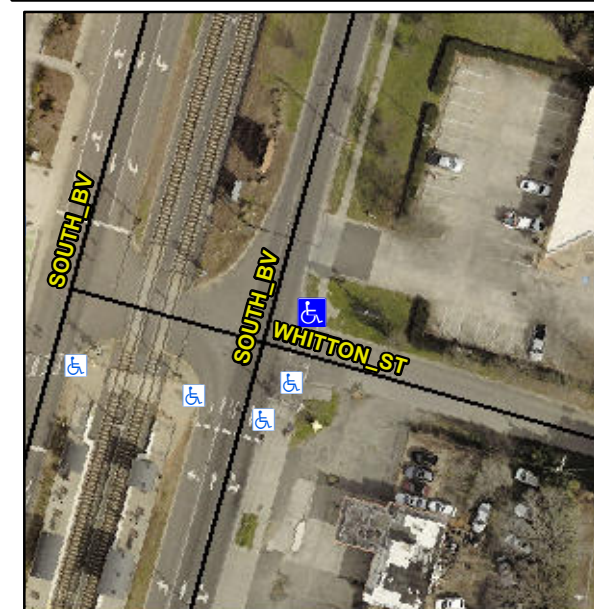
Not Found, R304.5.1, R304.2.2

Compliance	Description	Data	Compliance	Description	Data
N/A	Ramp Length (in)	71.5	No	Ramp Slope (%)	8.5
No	Ramp Width (in)	47.0	Yes	Ramp XSlope (%)	2.6
N/A	Flare Type LT	N/A	N/A	Flare Type RT	N/A
N/A	Flare Slope LT (%)	N/A	N/A	Flare Slope RT (%)	N/A
N/A	Flare Traversable LT?	N/A	N/A	Flare Traversable RT?	N/A
N/A	Landing Length (in)	N/A	N/A	DWS Provided?	N/A
N/A	Landing Width (in)	N/A	N/A	DWS Contrast?	N/A
N/A	Landing Slope (%)	N/A	N/A	DWS Length (in)	N/A
N/A	Landing X Slope (%)	N/A	N/A	DWS Full Width?	N/A
N/A	Landing Curb? (Y/N)	N/A	N/A	DWS Offset (in)	N/A
N/A	Shared Landing?	N/A			
N/A	Gutter Ponding?	N/A	N/A	Gutter Slope (%)	N/A
N/A	Gutter Lip Ht (in)	N/A	N/A	Gutter X Slope (%)	N/A
N/A	Painted X Walk1?	Yes	N/A	Painted X Walk2?	N/A
	X Walk 1 Direction	To SW		X Walk 2 Direction	N/A
N/A	X Walk 1 Width (in)	111.0	N/A	X Walk 2 Width (in)	N/A
	X Walk 1 Slope (%)	3.0		X Walk 2 Slope (%)	N/A
	X Walk 1 X Slope (%)	3.3		X Walk 2 X Slope (%)	N/A

N/A	Ramp inside XWalk1?	Yes	N/A	Ramp inside XWalk2?	N/A
	Road Slope (%)	N/A	N/A	Clear Space?	N/A
	Road X Slope (%)	N/A	N/A	Clear Space to XWalk (in)	N/A
N/A	Any Obstructions?	N/A	N/A	Storm Grate/Utility Hazard?	N/A
	Obstruction Type			Storm Grate/Utility Type	
		N/A			N/A
			Yes	Surface Condition? (G/P)	Good

Possible Solutions:

Remove & Replace Entire Ramp.
