Access Compliance Report

Public Rights-of-Way

(Curb Ramps)

| Intersection ID: 17298 | Main Street: IDLEWILD_RD | Cross Street: NEW_HAMPSHIRE_DR | Location: S |

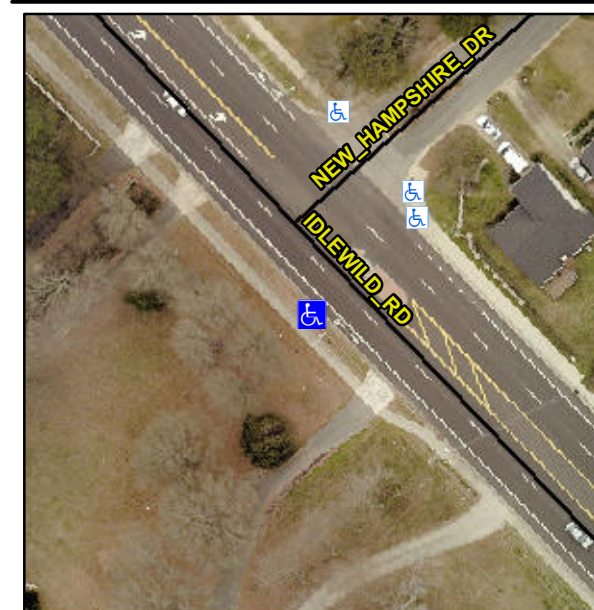
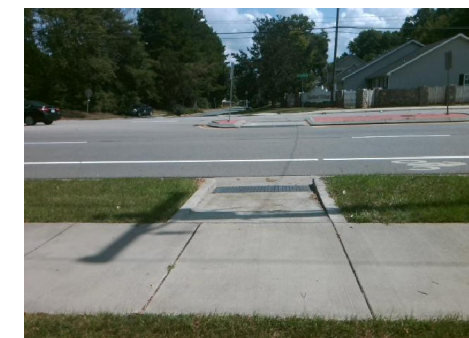
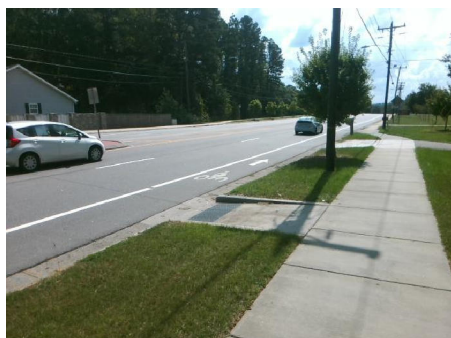
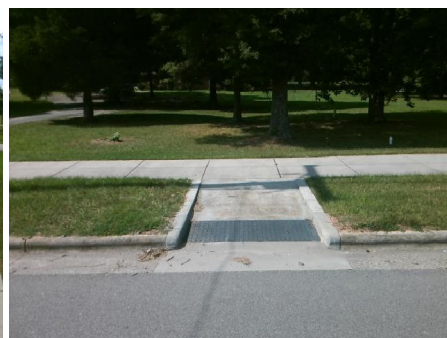
| ADA ID: 77D4D67EDB09 | Ramp Type: Perp | Initial Pass/Fail: Fail | Overall Compliance: No |

Not Found, R304.2.2

| Compliance | Description | Data | Compliance | Description | Data |
|---|---|---|---|---|---|
| N/A | Ramp Length (in) | 95.0 | No | Ramp Slope (%) | 9.2 |

Remove & Replace Entire Ramp.
