Access Compliance Report

Public Rights-of-Way

(Curb Ramps)

Intersection ID: 20185	Main Street: FAIRVIEW_RD	Cross Street: PIEDMONT_ROW_DR	Location: SE
ADA ID: 77EDA63150B0	Ramp Type: Perp	Initial Pass/Fail: Fail	Overall Compliance: No
Severity Score: 22.5			
Codes/Mitigation Info/Possible Solution		Field Measurements/Component Compliance

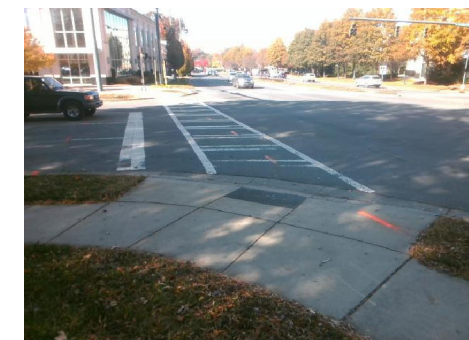
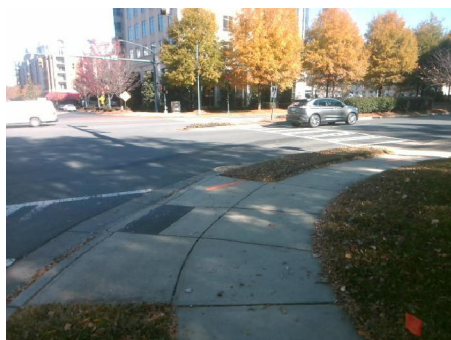
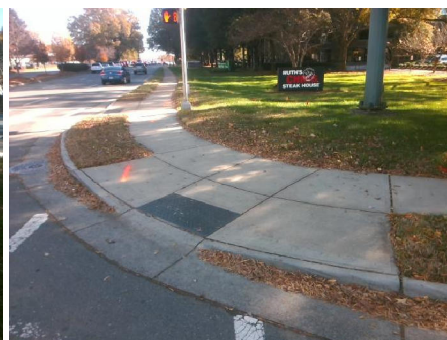
Not Found, R304.5.1, R304.2.2, R304.5.3

Compliance	Description	Data	Compliance	Description	Data
N/A	Ramp Length (in)	48.0	No	Ramp Slope (%)	8.5
No	Ramp Width (in)	47.0	No	Ramp XSlope (%)	2.4
N/A	Flare Type LT	N/A	N/A	Flare Type RT	N/A
N/A	Flare Slope LT (%)	N/A	N/A	Flare Slope RT (%)	N/A
N/A	Flare Traversable LT?	N/A	N/A	Flare Traversable RT?	N/A
N/A	Landing Length (in)	N/A	N/A	DWS Provided?	N/A
N/A	Landing Width (in)	N/A	N/A	DWS Contrast?	N/A
N/A	Landing Slope (%)	N/A	N/A	DWS Length (in)	N/A
N/A	Landing X Slope (%)	N/A	N/A	DWS Full Width?	N/A
N/A	Landing Curb? (Y/N)	N/A	N/A	DWS Offset (in)	N/A
N/A	Shared Landing?	N/A			
N/A	Gutter Ponding?	N/A	N/A	Gutter Slope (%)	N/A
N/A	Gutter Lip Ht (in)	N/A	N/A	Gutter X Slope (%)	N/A
N/A	Painted X Walk1?	Yes	N/A	Painted X Walk2?	N/A
	X Walk 1 Direction	To W		X Walk 2 Direction	N/A
N/A	X Walk 1 Width (in)	86.0	N/A	X Walk 2 Width (in)	N/A
	X Walk 1 Slope (%)	0.5		X Walk 2 Slope (%)	N/A
	X Walk 1 X Slope (%)	1.7		X Walk 2 X Slope (%)	N/A

N/A	Ramp inside XWalk1?	Yes	N/A	Ramp inside XWalk2?	N/A
	Road Slope (%)	N/A	N/A	Clear Space?	N/A
	Road X Slope (%)	N/A	N/A	Clear Space to XWalk (in)	N/A
N/A	Any Obstructions?	N/A	N/A	Storm Grate/Utility Hazard?	N/A
	Obstruction Type			Storm Grate/Utility Type	
		N/A			N/A
			Yes	Surface Condition? (G/P)	Good

Remove & Replace Entire Ramp.

Total Cost: \$ 1850.00
