# Access Compliance Report

## Public Rights-of-Way

| Intersection ID: 22417 | Main Street: BRACKENBURY_LN | Cross Street: N_BRACKENBURY_LN | Location: SW |
| ADA ID: 77F371650F0B | Ramp Type: PerpDiag | Initial Pass/Fail: Fail | Overall Compliance: No |

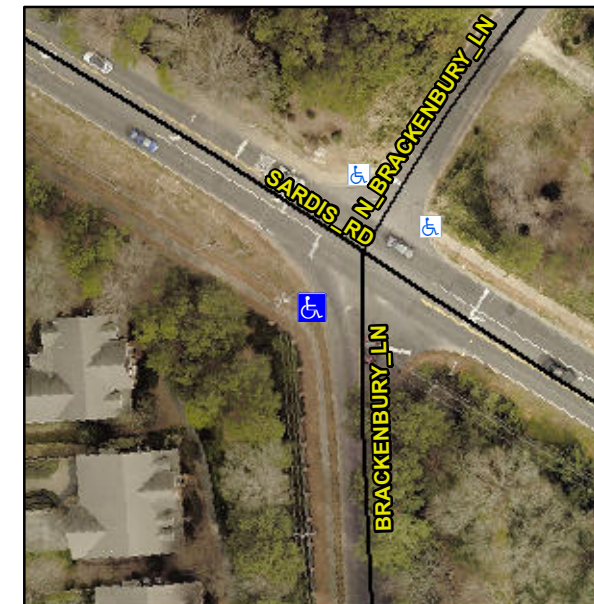
| | | Severity Score: 35 | |

**R304.5.1, R304.2.2, R304.5.3**

| Compliance | Description | Data | Compliance | Description | Data |
|---|---|---|---|---|---|
| N/A | Ramp Length (in) | 127.0 | No | Ramp Slope (%) | 12.0 |
| No | Ramp Width (in) | 47.0 | No | Ramp XSlope (%) | 4.2 |

**Remove & Replace Curb Ramp With Two New Directional Ramps or Equivalent.**
