Access Compliance Report

Public Rights-of-Way

(Curb Ramps)

Intersection ID: 51575	Main Street: THRIFT_RD	Cross Street: RUSHING_CREEK_LN	Location:	N
ADA ID: 77F3B45CF6CF	Ramp Type: Perp	Initial Pass/Fail: Fail	Overall Compliance: No	Severity Score: 21.25
Codes/Mitigation Info/Possible Solution		Field Measurements/Component Compliance

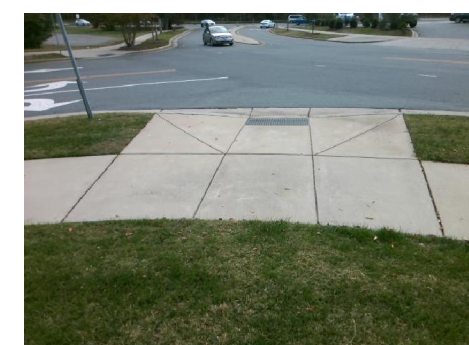
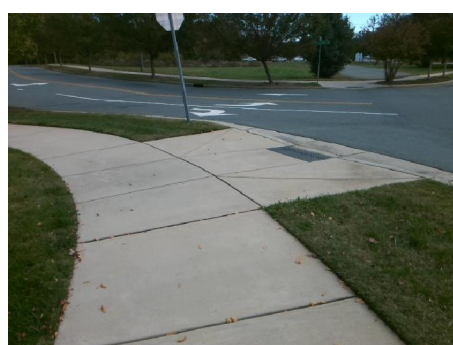
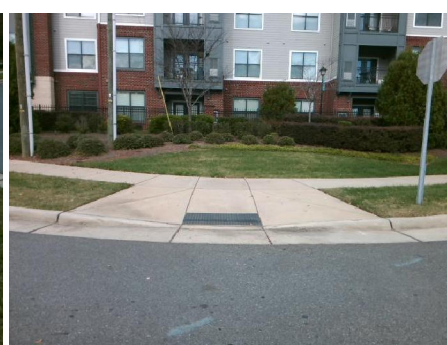
Not Found, R304.5.1, R304.2.2

Compliance	Description	Data	Compliance	Description	Data
N/A	Ramp Length (in)	96.0	No	Ramp Slope (%)	8.7
No	Ramp Width (in)	47.0	Yes	Ramp XSlope (%)	0.1
N/A	Flare Type LT	N/A	N/A	Flare Type RT	N/A
N/A	Flare Slope LT (%)	N/A	N/A	Flare Slope RT (%)	N/A
N/A	Flare Traversable LT?	N/A	N/A	Flare Traversable RT?	N/A
N/A	Landing Length (in)	N/A	N/A	DWS Provided?	N/A
N/A	Landing Width (in)	N/A	N/A	DWS Contrast?	N/A
N/A	Landing Slope (%)	N/A	N/A	DWS Length (in)	N/A
N/A	Landing X Slope (%)	N/A	N/A	DWS Full Width?	N/A
N/A	Landing Curb? (Y/N)	N/A	N/A	DWS Offset (in)	N/A
N/A	Shared Landing?	N/A			
N/A	Gutter Ponding?	N/A	N/A	Gutter Slope (%)	N/A
N/A	Gutter Lip Ht (in)	N/A	N/A	Gutter X Slope (%)	N/A
N/A	Painted X Walk1?	No	N/A	Painted X Walk2?	N/A
	X Walk 1 Direction	To SE		X Walk 2 Direction	N/A
N/A	X Walk 1 Width (in)	N/A	N/A	X Walk 2 Width (in)	N/A
	X Walk 1 Slope (%)	4.2		X Walk 2 Slope (%)	N/A
	X Walk 1 X Slope (%)	1.6		X Walk 2 X Slope (%)	N/A

N/A	Ramp inside XWalk1?	N/A	N/A	Ramp inside XWalk2?	N/A
	Road Slope (%)	N/A	N/A	Clear Space?	N/A
	Road X Slope (%)	N/A	N/A	Clear Space to XWalk (in)	N/A
N/A	Any Obstructions?	N/A	N/A	Storm Grate/Utility Hazard?	N/A
	Obstruction Type			Storm Grate/Utility Type	
		N/A			N/A
			Yes	Surface Condition? (G/P)	Good

Remove & Replace Entire Ramp.
