Access Compliance Report

Public Rights-of-Way

(Curb Ramps)

Intersection ID: 2853	Main Street: CARDINAL_POINT_RD	Cross Street: BENFIELD_RD	Location: SE
ADA ID: 77F96A9AE188	Ramp Type: Directional1	Initial Pass/Fail: Pass	Overall Compliance: No
Severity Score: 5.25			
Codes/Mitigation Info/Possible Solution		Field Measurements/Component Compliance

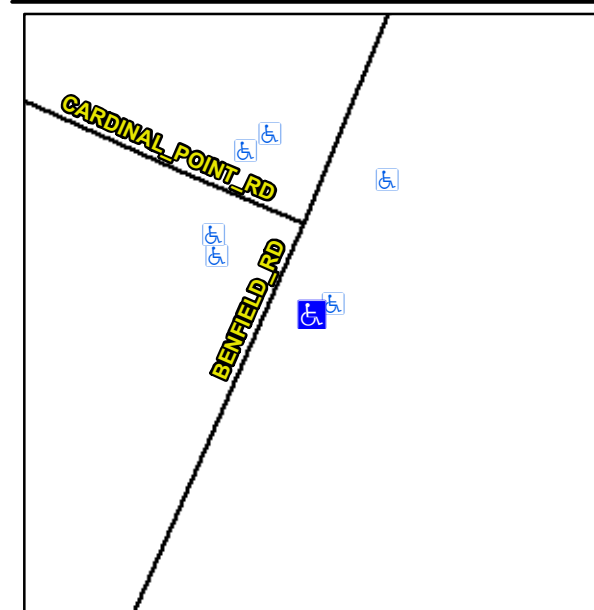
R304.5.3, R304.2.3

Compliance	Description	Data	Compliance	Description	Data
N/A	Ramp Length (in)	57.0	N/A	Grade Break?	N/A
Yes	Ramp Width (in)	69.0	N/A	Grade Break Slope (%)	0.0
Yes	Ramp Slope (%)	3.5	N/A	Grade Break XSlope (%)	0.0
No	Ramp XSlope (%)	2.2			
No	Flare Type LT	N/A	Yes	Flare Type RT	N/A
N/A	Flare Slope LT (%)	N/A	N/A	Flare Slope RT (%)	N/A
N/A	Flare Traversable LT?	No	N/A	Flare Traversable RT?	No
Yes	Landing Length (in)	72.0	Yes	DWS Provided?	Yes
Yes	Landing Width (in)	71.0	Yes	DWS Contrast?	Yes
Yes	Landing Slope (%)	0.5	Yes	DWS Length (in)	24.0
Yes	Landing X Slope (%)	0.8	Yes	DWS Full Width?	Yes
N/A	Landing Curb? (Y/N)	No	Yes	DWS Offset LT (in)	0.0
N/A	Shared Landing?	Yes	Yes	DWS Offset RT (in)	33.0
Yes	Gutter Ponding?	No	Yes	Gutter Slope (%)	0.7
Yes	Gutter Lip Ht (in)	0.0	Yes	Gutter X Slope (%)	1.3
N/A	Painted X Walk1?	No		Road Slope (%)	2.0
	X Walk 1 Direction	To NW		Road X Slope (%)	0.2
	X Walk 1 Width (in)	N/A		Clear Space?	Yes

X Walk 1 Slope (%)	2.0	N/A	Clear Space to XWalk (in)	N/A
	X Walk 1 X Slope (%)	0.2	Yes	Storm Grate/Utility Hazard?	No
N/A	Ramp inside XWalk1?	N/A		Storm Grate/Utility Type	
Yes	Any Obstructions?	No			N/A
	Obstruction Type		Yes	Surface Condition? (G/P)	Good
			N/A	Curb Slope (%)	N/A

Remove & Replace Entire Ramp.
