# Access Compliance Report

## Public Rights-of-Way

### (Curb Ramps)

Intersection ID: 14014	Main Street: N_SHARON_AMITY_RD	Cross Street: WILORA_LAKE_RD	Location: SW
ADA ID: 77FE65C65438	Ramp Type: Perp	Initial Pass/Fail: Fail	Overall Compliance: No
			Severity Score: 21.25

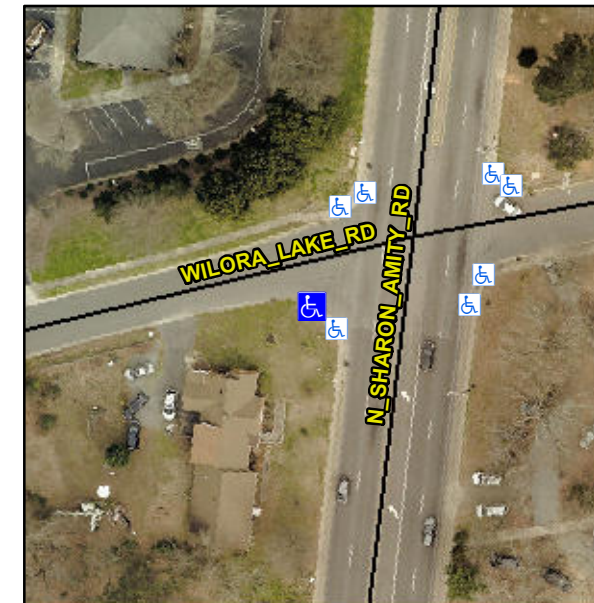
**Not Found, R304.5.1, R304.2.2**

Compliance	Description	Data	Compliance	Description	Data
N/A	Ramp Length (in)	57.5	No	Ramp Slope (%)	10.5
No	Ramp Width (in)	38.0	Yes	Ramp XSlope (%)	0.5
N/A	Flare Type LT	N/A	N/A	Flare Type RT	N/A
N/A	Flare Slope LT (%)	N/A	N/A	Flare Slope RT (%)	N/A
N/A	Flare Traversable LT?	N/A	N/A	Flare Traversable RT?	N/A
N/A	Landing Length (in)	N/A	N/A	DWS Provided?	N/A
N/A	Landing Width (in)	N/A	N/A	DWS Contrast?	N/A
N/A	Landing Slope (%)	N/A	N/A	DWS Length (in)	N/A
N/A	Landing X Slope (%)	N/A	N/A	DWS Full Width?	N/A
N/A	Landing Curb? (Y/N)	N/A	N/A	DWS Offset (in)	N/A
N/A	Shared Landing?	N/A			
N/A	Gutter Ponding?	Yes	N/A	Gutter Slope (%)	N/A
N/A	Gutter Lip Ht (in)	N/A	N/A	Gutter X Slope (%)	N/A
N/A	Painted X Walk1?	No	N/A	Painted X Walk2?	N/A
	X Walk 1 Direction	To NE		X Walk 2 Direction	N/A
N/A	X Walk 1 Width (in)	N/A	N/A	X Walk 2 Width (in)	N/A
	X Walk 1 Slope (%)	2.3		X Walk 2 Slope (%)	N/A
	X Walk 1 X Slope (%)	1.3		X Walk 2 X Slope (%)	N/A

N/A	Ramp inside XWalk1?	N/A	N/A	Ramp inside XWalk2?	N/A
	Road Slope (%)	N/A	N/A	Clear Space?	N/A
	Road X Slope (%)	N/A	N/A	Clear Space to XWalk (in)	N/A
N/A	Any Obstructions?	N/A	N/A	Storm Grate/Utility Hazard?	N/A
	Obstruction Type			Storm Grate/Utility Type	
		N/A			N/A
			Yes	Surface Condition? (G/P)	Good

**Remove & Replace Entire Ramp.**

Total Cost: \$ 1850.00
