# Access Compliance Report

## Public Rights-of-Way

### (Curb Ramps)

Intersection ID: 18007	Main Street: BRAEWICK_PL	Cross Street: IDLEWILD_RD	Location:	N
ADA ID: 780EA6A39D7D	Ramp Type: BlendTrans2	Initial Pass/Fail: Fail	Overall Compliance: No	Severity Score: 8.75

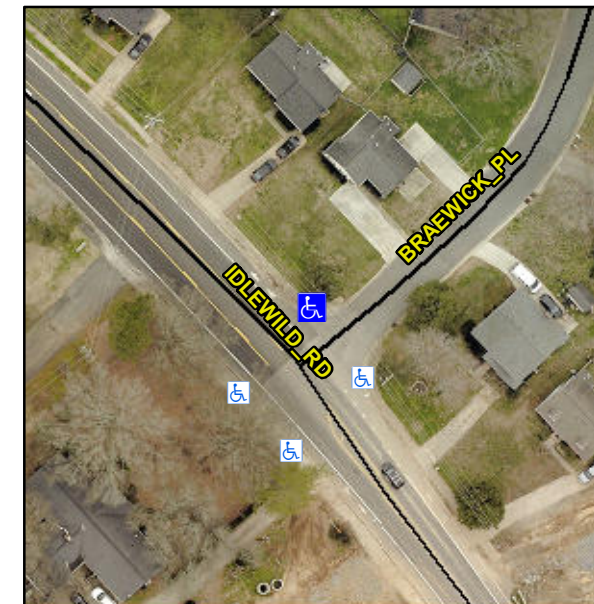
**Not Found, R304.5.1**

Compliance	Description	Data	Compliance	Description	Data
N/A	Ramp Length (in)	52.0	Yes	BlendTrans Slope (%)	3.6
No	Ramp Width (in)	47.0	Yes	BlendTrans XSlope (%)	0.0
N/A	Flare Type LT	N/A	N/A	Flare Type RT	N/A
N/A	Flare Slope LT (%)	N/A	N/A	Flare Slope RT (%)	N/A
N/A	Flare Traversable LT?	N/A	N/A	Flare Traversable RT?	N/A
N/A	Landing Length (in)	N/A	N/A	DWS Provided?	N/A
N/A	Landing Width (in)	N/A	N/A	DWS Contrast?	N/A
N/A	Landing Slope (%)	N/A	N/A	DWS Length (in)	N/A
N/A	Landing X Slope (%)	N/A	N/A	DWS Full Width?	N/A
N/A	Landing Curb? (Y/N)	N/A	N/A	DWS Offset (in)	N/A
N/A	Shared Landing?	N/A			
N/A	Gutter Ponding?	N/A	N/A	Gutter Slope (%)	N/A
N/A	Gutter Lip Ht (in)	N/A	N/A	Gutter X Slope (%)	N/A
N/A	Painted X Walk1?	No	N/A	Painted X Walk2?	No
	X Walk 1 Direction	To SW		X Walk 2 Direction	To SE
	X Walk 1 Width (in)	N/A		X Walk 2 Width (in)	N/A
	X Walk 1 Slope (%)	1.9		X Walk 2 Slope (%)	1.5
	X Walk 1 X Slope (%)	1.2		X Walk 2 X Slope (%)	4.2

N/A	Ramp inside XWalk1?	N/A	N/A	Ramp inside XWalk2?	N/A
	Road Slope (%)	1.1		Clear Space?	N/A
	Road X Slope (%)	5.2	N/A	Clear Space to XWalk (in)	N/A
N/A	Any Obstructions?	N/A	N/A	Storm Grate/Utility Hazard?	N/A
	Obstruction Type			Storm Grate/Utility Type	
		N/A			N/A
			Yes	Surface Condition? (G/P)	Good
			No	Curb Slope (%)	20.0

**Remove & Replace Curb Ramp With Two New Directional Ramps or Equivalent.**
