Access Compliance Report

Public Rights-of-Way

(Curb Ramps)

Intersection ID: 2983	Main Street: YELLOW_ROSE_LN	Cross Street: BROWNE_RD	Location: SE
ADA ID: 7813CB02AB4B	Ramp Type: Perp	Initial Pass/Fail: Fail	Overall Compliance: No
Codes/Mitigation Info/Possible Solution		Field Measurements/Component Compliance	
Severity Score: 33.75

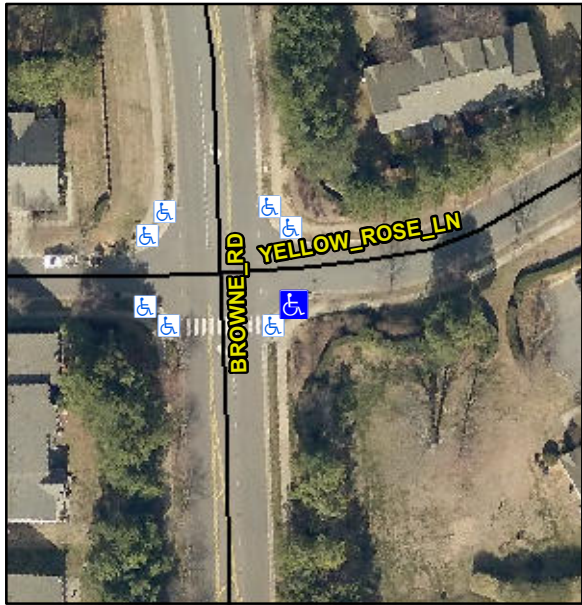
Compliance	Description	Data	Compliance	Description	Data
N/A	Ramp Length (in)	61.0	No	Ramp Slope (%)	8.9
No	Ramp Width (in)	44.0	No	Ramp XSlope (%)	6.1
N/A	Flare Type LT	N/A	N/A	Flare Type RT	N/A
N/A	Flare Slope LT (%)	N/A	N/A	Flare Slope RT (%)	N/A
N/A	Flare Traversable LT?	N/A	N/A	Flare Traversable RT?	N/A
N/A	Landing Length (in)	N/A	N/A	DWS Provided?	N/A
N/A	Landing Width (in)	N/A	N/A	DWS Contrast?	N/A
N/A	Landing Slope (%)	N/A	N/A	DWS Length (in)	N/A
N/A	Landing X Slope (%)	N/A	N/A	DWS Full Width?	N/A
N/A	Landing Curb? (Y/N)	N/A	N/A	DWS Offset (in)	N/A
N/A	Shared Landing?	N/A			
N/A	Gutter Ponding?	N/A	N/A	Gutter Slope (%)	N/A
N/A	Gutter Lip Ht (in)	N/A	N/A	Gutter X Slope (%)	N/A
N/A	Painted X Walk1?	No	N/A	Painted X Walk2?	N/A
	X Walk 1 Direction	To N		X Walk 2 Direction	N/A
N/A	X Walk 1 Width (in)	N/A	N/A	X Walk 2 Width (in)	N/A
	X Walk 1 Slope (%)	0.2		X Walk 2 Slope (%)	N/A
	X Walk 1 X Slope (%)	4.6		X Walk 2 X Slope (%)	N/A

N/A	Ramp inside XWalk1?	N/A	N/A	Ramp inside XWalk2?	N/A
	Road Slope (%)	N/A	N/A	Clear Space?	N/A
	Road X Slope (%)	N/A	N/A	Clear Space to XWalk (in)	N/A
N/A	Any Obstructions?	N/A	N/A	Storm Grate/Utility Hazard?	N/A
	Obstruction Type			Storm Grate/Utility Type	
		N/A			N/A
			Yes	Surface Condition? (G/P)	Good

Possible Solutions:									
	Remove & Replace Entire Ramp.									
	Surveyor Notes:									
	N/A									
	PROW/ADA:									
	R304.5.1, R304.2.2, R304.5.3									
	Total Cost:	\$	1850.00							
Street 1 Name		YELLOW ROSE LN								
Stop Condition-Street 2		StopSign								
Street 2 Name		N/A								
Stop Condition-Street 1		N/A
