Access Compliance Report

Public Rights-of-Way

(Curb Ramps)

Intersection ID: 3083	Main Street: LOGANVILLE_DR	Cross Street: PANTHERSVILLE_DR	Location: NE
ADA ID: 781EA7EF6B3E	Ramp Type: Perp	Initial Pass/Fail: Fail	Overall Compliance: No
Codes/Mitigation Info/Possible Solution		Field Measurements/Component Compliance	
Severity Score: 61.25

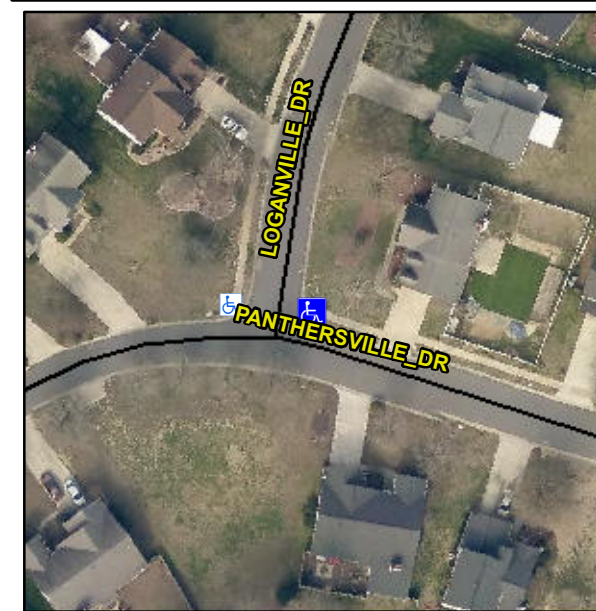
R304.5.1, R304.2.2, R304.5.3

Compliance	Description	Data	Compliance	Description	Data
N/A	Ramp Length (in)	96.5	No	Ramp Slope (%)	12.2
No	Ramp Width (in)	30.0	No	Ramp XSlope (%)	4.1
N/A	Flare Type LT	N/A	N/A	Flare Type RT	N/A
N/A	Flare Slope LT (%)	N/A	N/A	Flare Slope RT (%)	N/A
N/A	Flare Traversable LT?	N/A	N/A	Flare Traversable RT?	N/A
N/A	Landing Length (in)	N/A	N/A	DWS Provided?	N/A
N/A	Landing Width (in)	N/A	N/A	DWS Contrast?	N/A
N/A	Landing Slope (%)	N/A	N/A	DWS Length (in)	N/A
N/A	Landing X Slope (%)	N/A	N/A	DWS Full Width?	N/A
N/A	Landing Curb? (Y/N)	N/A	N/A	DWS Offset (in)	N/A
N/A	Shared Landing?	N/A			
N/A	Gutter Ponding?	N/A	N/A	Gutter Slope (%)	N/A
N/A	Gutter Lip Ht (in)	N/A	N/A	Gutter X Slope (%)	N/A
N/A	Painted X Walk1?	No	N/A	Painted X Walk2?	N/A
	X Walk 1 Direction	To W		X Walk 2 Direction	N/A
N/A	X Walk 1 Width (in)	N/A	N/A	X Walk 2 Width (in)	N/A
	X Walk 1 Slope (%)	0.6		X Walk 2 Slope (%)	N/A
	X Walk 1 X Slope (%)	3.8		X Walk 2 X Slope (%)	N/A

N/A	Ramp inside XWalk1?	N/A	N/A	Ramp inside XWalk2?	N/A
	Road Slope (%)	N/A	N/A	Clear Space?	N/A
	Road X Slope (%)	N/A	N/A	Clear Space to XWalk (in)	N/A
N/A	Any Obstructions?	N/A	N/A	Storm Grate/Utility Hazard?	N/A
	Obstruction Type			Storm Grate/Utility Type	
		N/A			N/A
			Yes	Surface Condition? (G/P)	Good

Possible Solutions:

Remove & Replace Entire Ramp.
