Access Compliance Report

Public Rights-of-Way

(Curb Ramps)

Intersection ID: N/A	Main Street: GROVER RD	Cross Street: N/A	Location: W
ADA ID: 78253152CA82	Ramp Type: Perp	Initial Pass/Fail: Fail	Overall Compliance: No
Codes/Mitigation Info/Possible Solution		Field Measurements/Component Compliance	
Severity Score: 13.75

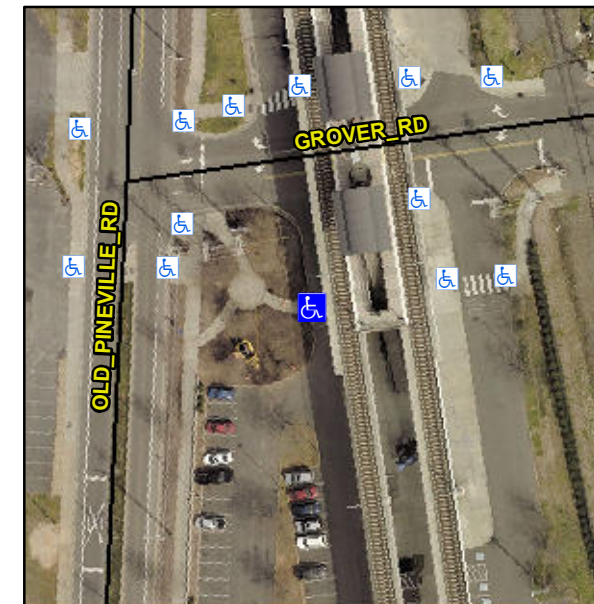
R304.2.2, R304.5.3

Compliance	Description	Data	Compliance	Description	Data
N/A	Ramp Length (in)	72.0	No	Ramp Slope (%)	9.4
Yes	Ramp Width (in)	48.0	No	Ramp XSlope (%)	2.2
N/A	Flare Type LT	N/A	N/A	Flare Type RT	N/A
N/A	Flare Slope LT (%)	N/A	N/A	Flare Slope RT (%)	N/A
N/A	Flare Traversable LT?	No	N/A	Flare Traversable RT?	No
N/A	Landing Length (in)	N/A	N/A	DWS Provided?	N/A
N/A	Landing Width (in)	N/A	N/A	DWS Contrast?	N/A
N/A	Landing Slope (%)	N/A	N/A	DWS Length (in)	N/A
N/A	Landing X Slope (%)	N/A	N/A	DWS Full Width?	N/A
N/A	Landing Curb? (Y/N)	N/A	N/A	DWS Offset (in)	N/A
N/A	Shared Landing?	N/A			
N/A	Gutter Ponding?	N/A	N/A	Gutter Slope (%)	N/A
N/A	Gutter Lip Ht (in)	N/A	N/A	Gutter X Slope (%)	N/A
N/A	Painted X Walk1?	Yes	N/A	Painted X Walk2?	N/A
	X Walk 1 Direction	To E		X Walk 2 Direction	N/A
N/A	X Walk 1 Width (in)	125.0	N/A	X Walk 2 Width (in)	N/A
	X Walk 1 Slope (%)	0.3		X Walk 2 Slope (%)	N/A
	X Walk 1 X Slope (%)	0.2		X Walk 2 X Slope (%)	N/A

N/A	Ramp inside XWalk1?	Yes	N/A	Ramp inside XWalk2?	N/A
	Road Slope (%)	N/A	N/A	Clear Space?	N/A
	Road X Slope (%)	N/A	N/A	Clear Space to XWalk (in)	N/A
N/A	Any Obstructions?	N/A	N/A	Storm Grate/Utility Hazard?	N/A
	Obstruction Type			Storm Grate/Utility Type	
		N/A			N/A
			Yes	Surface Condition? (G/P)	Good

Possible Solutions:

Remove & Replace Entire Ramp.
