Access Compliance Report

Public Rights-of-Way

(Curb Ramps)

| Intersection ID: 50631 | Main Street: CORAL_ROSE_RD | Cross Street: RUBY_VALLEY_RD | Location: NE |

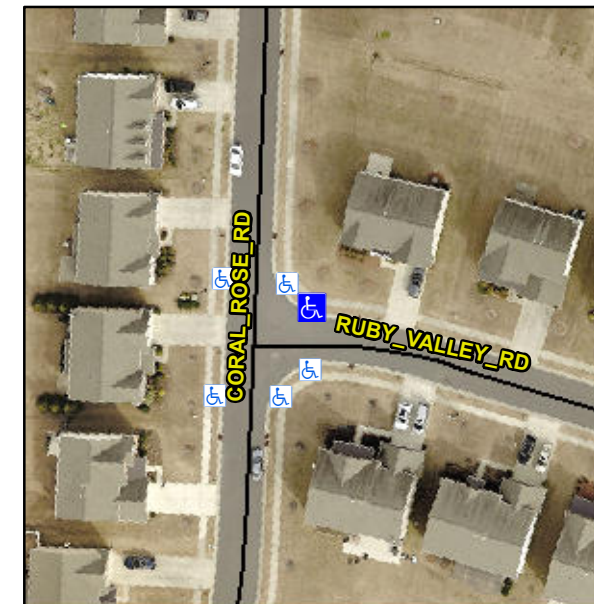
| ADA ID: 783B0D1E1EA7 | Ramp Type: Perp | Initial Pass/Fail: Fail | Overall Compliance: No |
| | | Severity Score: 10 | |

Not Found, R304.5.1, R304.5.3

| Compliance | Description | Data | Compliance | Description | Data |
|---|---|---|---|---|---|
| N/A | Ramp Length (in) | 46.5 | Yes | Ramp Slope (%) | 6.0 |
| No | Ramp Width (in) | 47.0 | No | Ramp XSlope (%) | 2.2 |

Possible Solutions:

Remove & Replace Entire Ramp.

Total Cost: \$ 1850.00
