Access Compliance Report

Public Rights-of-Way

(Curb Ramps)

Intersection ID: 19326	Main Street: BEACON_RIDGE_RD	Cross Street: SOUTH_BV	Location: SE
ADA ID: 783C6AA8098F	Ramp Type: Directional1	Initial Pass/Fail: Fail	Overall Compliance: No
		Severity Score: 25

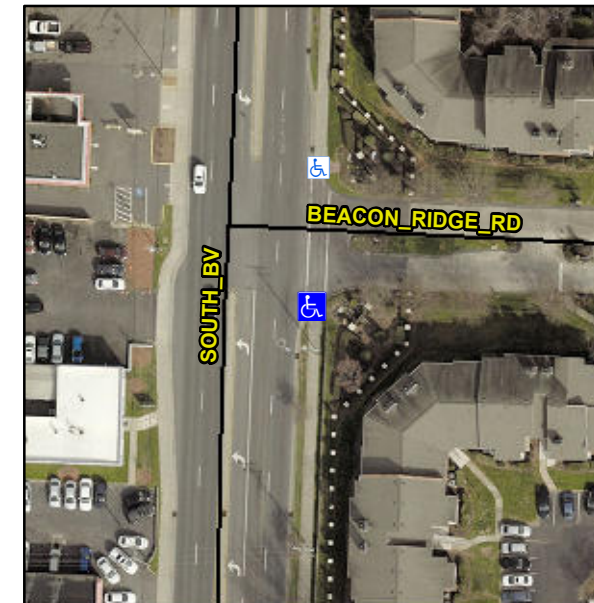
R304.5.3

Compliance	Description	Data	Compliance	Description	Data
N/A	Ramp Length (in)	80.0	N/A	Grade Break?	N/A
Yes	Ramp Width (in)	70.0	N/A	Grade Break Slope (%)	0.0
Yes	Ramp Slope (%)	6.7	N/A	Grade Break XSlope (%)	0.0
No	Ramp XSlope (%)	7.3			
N/A	Flare Type LT	N/A	N/A	Flare Type RT	N/A
N/A	Flare Slope LT (%)	N/A	N/A	Flare Slope RT (%)	0.0
N/A	Flare Traversable LT?	N/A	N/A	Flare Traversable RT?	N/A
N/A	Landing Length (in)	0.0	N/A	DWS Provided?	N/A
N/A	Landing Width (in)	0.0	N/A	DWS Contrast?	N/A
N/A	Landing Slope (%)	0.0	N/A	DWS Length (in)	N/A
N/A	Landing X Slope (%)	0.0	N/A	DWS Full Width?	N/A
N/A	Landing Curb? (Y/N)	N/A	N/A	DWS Offset LT (in)	N/A
N/A	Shared Landing?	N/A	N/A	DWS Offset RT (in)	N/A
N/A	Gutter Ponding?	0.0	N/A	Gutter Slope (%)	N/A
N/A	Gutter Lip Ht (in)	0.0	N/A	Gutter X Slope (%)	N/A
N/A	Painted X Walk1?	Yes		Road Slope (%)	5.5
	X Walk 1 Direction	To NW		Road X Slope (%)	9.2
	X Walk 1 Width (in)	110.0		Clear Space?	N/A

X Walk 1 Slope (%)	5.5	N/A	Clear Space to XWalk (in)	N/A
	X Walk 1 X Slope (%)	9.2	N/A	Storm Grate/Utility Hazard?	N/A
N/A	Ramp inside XWalk1?	Yes		Storm Grate/Utility Type	
N/A	Any Obstructions?	N/A			N/A
	Obstruction Type		Yes	Surface Condition? (G/P)	Good
			N/A	Curb Slope (%)	9.0

Possible Solutions:

Remove & Replace Entire Ramp.
