Intersection ID: 17776	Main Street: CHELSEA_DR	Cross Street: TRANQUIL_AV	Location:	SW
ADA ID: 783F239E7872	Ramp Type: PerpDiag	Initial Pass/Fail: Fail	Overall Compliance: No	Severity Score: 12.5

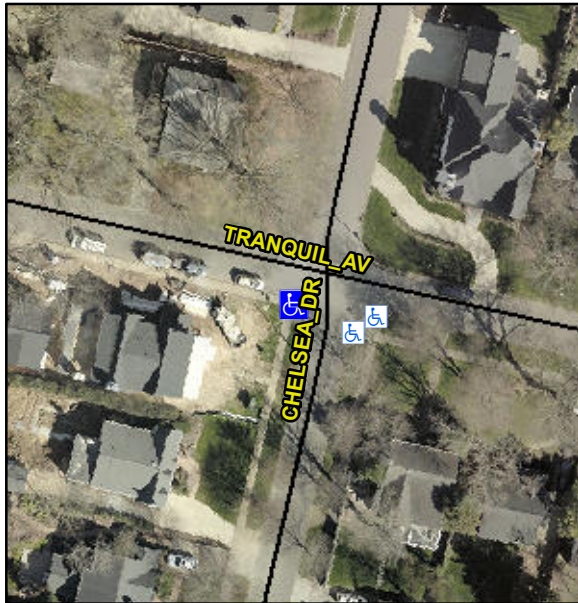
Not Found, R304.5.3

Compliance	Description	Data	Compliance	Description	Data
N/A	Ramp Length (in)	69.0	Yes	Ramp Slope (%)	8.3
Yes	Ramp Width (in)	48.0	No	Ramp XSlope (%)	6.0
N/A	Flare Type LT	N/A	N/A	Flare Type RT	N/A
N/A	Flare Slope LT (%)	N/A	N/A	Flare Slope RT (%)	N/A
N/A	Flare Traversable LT?	N/A	N/A	Flare Traversable RT?	N/A
N/A	Landing Length (in)	N/A	N/A	DWS Provided?	N/A
N/A	Landing Width (in)	N/A	N/A	DWS Contrast?	N/A
N/A	Landing Slope (%)	N/A	N/A	DWS Length (in)	N/A
N/A	Landing X Slope (%)	N/A	N/A	DWS Full Width?	N/A
N/A	Landing Curb? (Y/N)	N/A	N/A	DWS Offset (in)	N/A
N/A	Shared Landing?	N/A			
N/A	Gutter Ponding?	N/A	N/A	Gutter Slope (%)	N/A
N/A	Gutter Lip Ht (in)	N/A	N/A	Gutter X Slope (%)	N/A
N/A	Painted X Walk1?	No	N/A	Painted X Walk2?	No
	X Walk 1 Direction	To SE		X Walk 2 Direction	To NE
N/A	X Walk 1 Width (in)	N/A	N/A	X Walk 2 Width (in)	N/A
	X Walk 1 Slope (%)	0.2		X Walk 2 Slope (%)	2.6
	X Walk 1 X Slope (%)	4.0		X Walk 2 X Slope (%)	1.0

N/A	Ramp inside XWalk1?	N/A	N/A	Ramp inside XWalk2?	N/A
	Road Slope (%)	2.4	N/A	Clear Space?	N/A
	Road X Slope (%)	4.4	N/A	Clear Space to XWalk (in)	N/A
N/A	Any Obstructions?	N/A	N/A	Storm Grate/Utility Hazard?	N/A
	Obstruction Type			Storm Grate/Utility Type	
		N/A			N/A
			Yes	Surface Condition? (G/P)	Good

Possible Solutions:

Remove & Replace Curb Ramp With Two New Directional Ramps or Equivalent.
