Access Compliance Report

Public Rights-of-Way

(Curb Ramps)

Intersection ID: 15236	Main Street: CARLING_AV	Cross Street: DILWORTH_RD_EAST	Location: E
ADA ID: 7845EBE3F2DE	Ramp Type: Perp	Initial Pass/Fail: Fail	Overall Compliance: No
Severity Score: 26.25			
Codes/Mitigation Info/Possible Solution		Field Measurements/Component Compliance

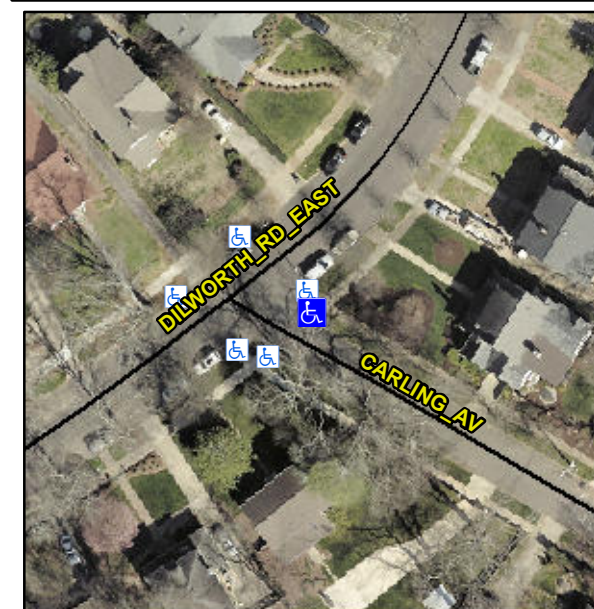
PROW/ADA:

R304.2.2, R304.5.3

Compliance	Description	Data	Compliance	Description	Data
N/A	Ramp Length (in)	75.0	No	Ramp Slope (%)	12.9
Yes	Ramp Width (in)	48.0	No	Ramp XSlope (%)	2.4
N/A	Flare Type LT	N/A	N/A	Flare Type RT	N/A
N/A	Flare Slope LT (%)	N/A	N/A	Flare Slope RT (%)	N/A
N/A	Flare Traversable LT?	N/A	N/A	Flare Traversable RT?	N/A
N/A	Landing Length (in)	N/A	N/A	DWS Provided?	N/A
N/A	Landing Width (in)	N/A	N/A	DWS Contrast?	N/A
N/A	Landing Slope (%)	N/A	N/A	DWS Length (in)	N/A
N/A	Landing X Slope (%)	N/A	N/A	DWS Full Width?	N/A
N/A	Landing Curb? (Y/N)	N/A	N/A	DWS Offset (in)	N/A
N/A	Shared Landing?	N/A			
N/A	Gutter Ponding?	N/A	N/A	Gutter Slope (%)	N/A
N/A	Gutter Lip Ht (in)	1.0	N/A	Gutter X Slope (%)	N/A
N/A	Painted X Walk1?	No	N/A	Painted X Walk2?	N/A
	X Walk 1 Direction	To SW		X Walk 2 Direction	N/A
N/A	X Walk 1 Width (in)	N/A	N/A	X Walk 2 Width (in)	N/A
	X Walk 1 Slope (%)	4.4		X Walk 2 Slope (%)	N/A
	X Walk 1 X Slope (%)	2.6		X Walk 2 X Slope (%)	N/A

N/A	Ramp inside XWalk1?	N/A	N/A	Ramp inside XWalk2?	N/A
	Road Slope (%)	N/A	N/A	Clear Space?	N/A
	Road X Slope (%)	N/A	N/A	Clear Space to XWalk (in)	N/A
N/A	Any Obstructions?	N/A	N/A	Storm Grate/Utility Hazard?	N/A
	Obstruction Type			Storm Grate/Utility Type	
		N/A			N/A
			Yes	Surface Condition? (G/P)	Good

Possible Solutions:

Remove & Replace Entire Ramp.
