Access Compliance Report

(Curb Ramps)

| Intersection ID: 9661 | Main Street: CAMROSE_DR | Cross Street: THE_PLAZA | Location: NW |
| ADA ID: 7867FF35E5A8 | Ramp Type: Perp | Initial Pass/Fail: Pass | Overall Compliance: No |

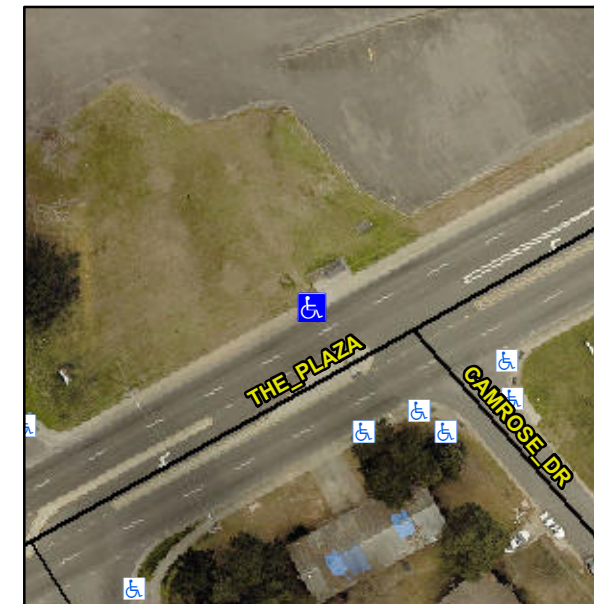
R304.2.1, R304.2.2-Perp, R304.3.2-Para, R304.5.3

| Compliance | Description | Data | Compliance | Description | Data |
|---|---|---|---|---|---|
| No | Landing Length (in) | N/A | Yes | DWS Provided? | Yes |
| No | Landing Width (in) | N/A | Yes | DWS Contrast? | Yes |
| No | Landing Slope (%) | N/A | Yes | DWS Length (in) | 24.0 |
| No | Landing X Slope (%) | N/A | Yes | DWS Full Width? | Yes |

Install Landing.

Total Cost: \$ 400.00
