# Access Compliance Report

## Public Rights-of-Way

### (Curb Ramps)

Intersection ID: 17707	Main Street: MELBA_DR	Cross Street: OLD_POST_RD	Location: NW
ADA ID: 786C7E1FEDB7	Ramp Type: ParaDiag	Initial Pass/Fail: Fail	Overall Compliance: No
			Severity Score: 13.75

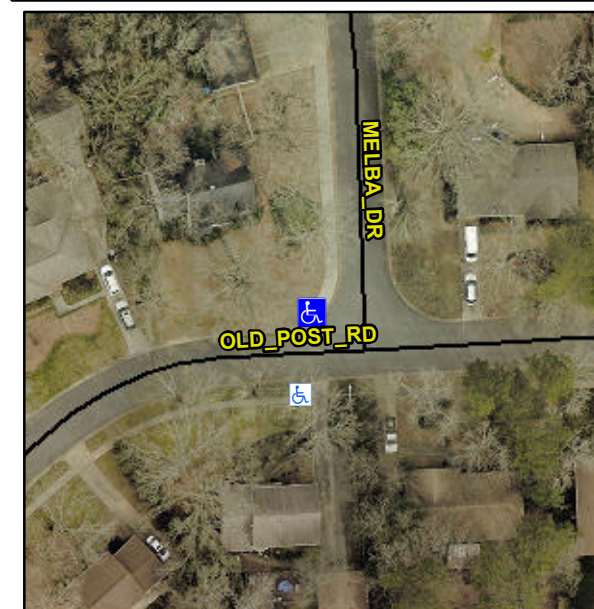
**RT RP < 5%**

Compliance	Description	Data	Compliance	Description	Data
N/A	Ramp Length LT (in)	27.0	N/A	Ramp Length RT (in)	53.0
Yes	Ramp Width LT (in)	73.0	Yes	Ramp Width RT (in)	72.0
No	Ramp Slope LT (%)	9.8	Yes	Ramp Slope RT (%)	2.5
No	Ramp XSlope LT (%)	2.1	Yes	Ramp XSlope RT (%)	1.5
N/A	Landing Length (in)	N/A	N/A	DWS Provided?	N/A
N/A	Landing Width (in)	N/A	N/A	DWS Contrast?	N/A
N/A	Landing Slope (%)	N/A	N/A	DWS Length (in)	N/A
N/A	Landing X Slope (%)	N/A	N/A	DWS Full Width?	N/A
N/A	Landing Curb? (Y/N)	N/A	N/A	DWS Offset (in)	N/A
N/A	Shared Landing?	N/A			
N/A	Gutter Ponding?	N/A	N/A	Gutter Slope (%)	N/A
N/A	Gutter Lip Ht (in)	N/A	N/A	Gutter X Slope (%)	N/A
N/A	Painted X Walk1?	No	N/A	Painted X Walk2?	No
	X Walk 1 Direction	To S		X Walk 2 Direction	To E
N/A	X Walk 1 Width (in)	N/A	N/A	X Walk 2 Width (in)	N/A
	X Walk 1 Slope (%)	5.1		X Walk 2 Slope (%)	1.7
	X Walk 1 X Slope (%)	0.3		X Walk 2 X Slope (%)	5.1
N/A	Ramp inside XWalk1?	N/A	N/A	Ramp inside XWalk2?	N/A

Road Slope (%)	1.0	N/A	Clear Space?	N/A
	Road X Slope (%)	6.5	N/A	Clear Space to XWalk (in)	N/A
N/A	Any Obstructions?	N/A	N/A	Storm Grate/Utility Hazard?	N/A
	Obstruction Type			Storm Grate/Utility Type	
		N/A			N/A
			Yes	Surface Condition? (G/P)	Good
			N/A	Curb Slope (%)	1.8

**Remove & Replace Curb Ramp With Two New Directional Ramps or Equivalent.**
