# Access Compliance Report

## Public Rights-of-Way

### (Curb Ramps)

| Intersection ID: 5686 | Main Street: STARMOUNT_AV | Cross Street: GREY_DOGWOOD_CT | Location: NW |

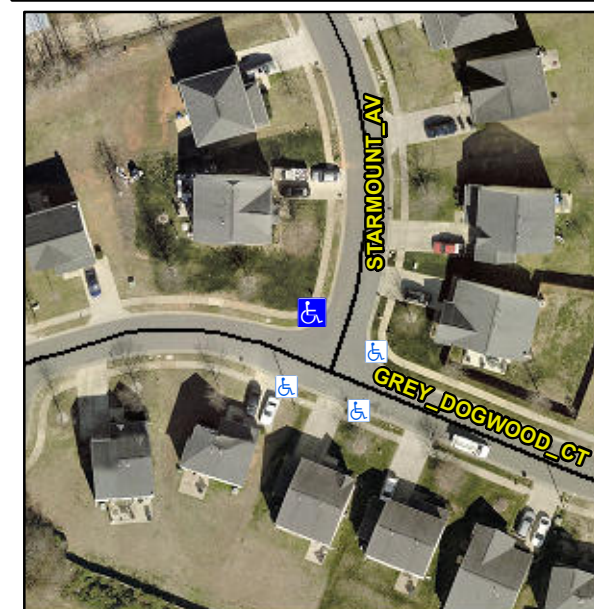
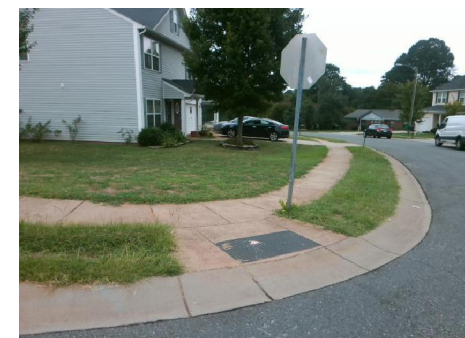
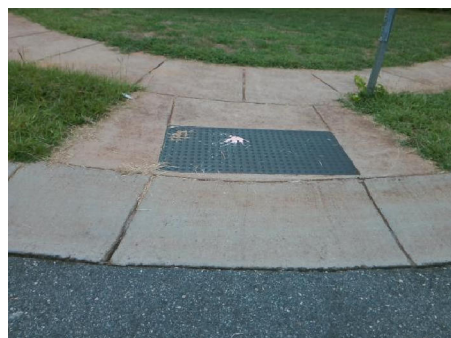
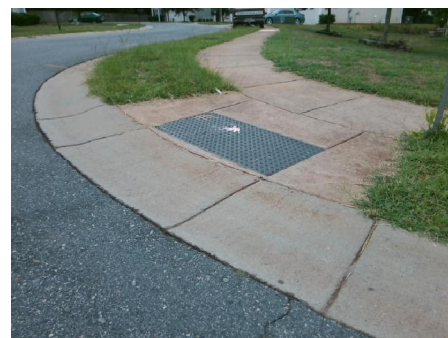
| ADA ID: 787798753473 | Ramp Type: BlendTrans1 | Initial Pass/Fail: Fail | Overall Compliance: No |
| Severity Score: 21.25 | | | |

**Not Found, R304.5.1, R304.5.3**

| Compliance | Description | Data | Compliance | Description | Data |
|---|---|---|---|---|---|
| No | Ramp Width (in) | 46.5 | No | BlendTrans XSlope (%) | 5.7 |

**Remove & Replace Curb Ramp With Two New Directional Ramps or Equivalent.**

Total Cost: \$ 3200.00
