# Access Compliance Report

## Public Rights-of-Way

### (Curb Ramps)

Intersection ID: 18881	Main Street: HONEGGER_DR	Cross Street: REDCOAT_DR	Location: NE
ADA ID: 787FCA055D6D	Ramp Type: PerpDiag	Initial Pass/Fail: Fail	Overall Compliance: No
Severity Score: 37.5			
Codes/Mitigation Info/Possible Solution		Field Measurements/Component Compliance

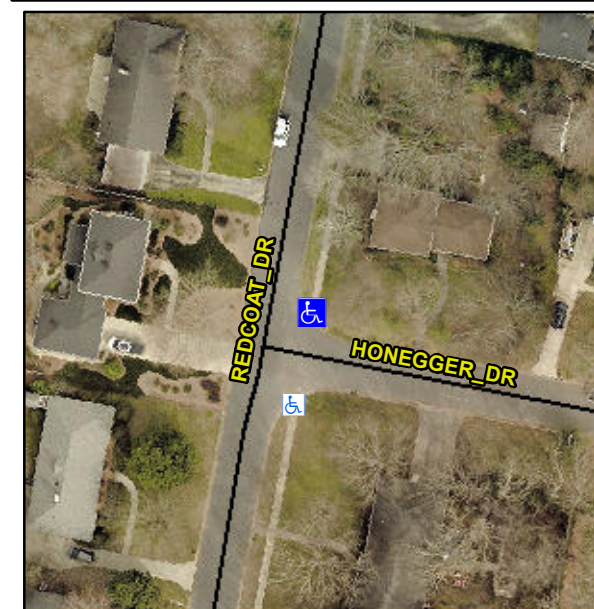
**Not Found, R304.2.2, R304.5.3**

Compliance	Description	Data	Compliance	Description	Data
N/A	Ramp Length (in)	25.0	No	Ramp Slope (%)	10.0
Yes	Ramp Width (in)	48.0	No	Ramp XSlope (%)	8.3
N/A	Flare Type LT	N/A	N/A	Flare Type RT	N/A
N/A	Flare Slope LT (%)	N/A	N/A	Flare Slope RT (%)	N/A
N/A	Flare Traversable LT?	N/A	N/A	Flare Traversable RT?	N/A
N/A	Landing Length (in)	N/A	N/A	DWS Provided?	N/A
N/A	Landing Width (in)	N/A	N/A	DWS Contrast?	N/A
N/A	Landing Slope (%)	N/A	N/A	DWS Length (in)	N/A
N/A	Landing X Slope (%)	N/A	N/A	DWS Full Width?	N/A
N/A	Landing Curb? (Y/N)	N/A	N/A	DWS Offset (in)	N/A
N/A	Shared Landing?	N/A			
N/A	Gutter Ponding?	N/A	N/A	Gutter Slope (%)	N/A
N/A	Gutter Lip Ht (in)	N/A	N/A	Gutter X Slope (%)	N/A
N/A	Painted X Walk1?	No	N/A	Painted X Walk2?	No
	X Walk 1 Direction	To NW		X Walk 2 Direction	To SW
N/A	X Walk 1 Width (in)	N/A	N/A	X Walk 2 Width (in)	N/A
	X Walk 1 Slope (%)	1.7		X Walk 2 Slope (%)	6.3
	X Walk 1 X Slope (%)	5.2		X Walk 2 X Slope (%)	2.0

N/A	Ramp inside XWalk1?	N/A	N/A	Ramp inside XWalk2?	N/A
	Road Slope (%)	6.8	N/A	Clear Space?	N/A
	Road X Slope (%)	4.5	N/A	Clear Space to XWalk (in)	N/A
N/A	Any Obstructions?	N/A	N/A	Storm Grate/Utility Hazard?	N/A
	Obstruction Type			Storm Grate/Utility Type	
		N/A			N/A
		Yes		Surface Condition? (G/P)	Good

**Remove & Replace Curb Ramp With Two New Directional Ramps or Equivalent.**

Total Cost: \$ 3200.00
