Access Compliance Report

Public Rights-of-Way

(Curb Ramps)

Intersection ID: 30487	Main Street: BEDDINGFIELD_DR	Cross Street: EBULLIENT_ST	Location: NW
ADA ID: 78843D73AF26	Ramp Type: PerpDiag	Initial Pass/Fail: Fail	Overall Compliance: No
Codes/Mitigation Info/Possible Solution		Field Measurements/Component Compliance	
Severity Score: 48.75

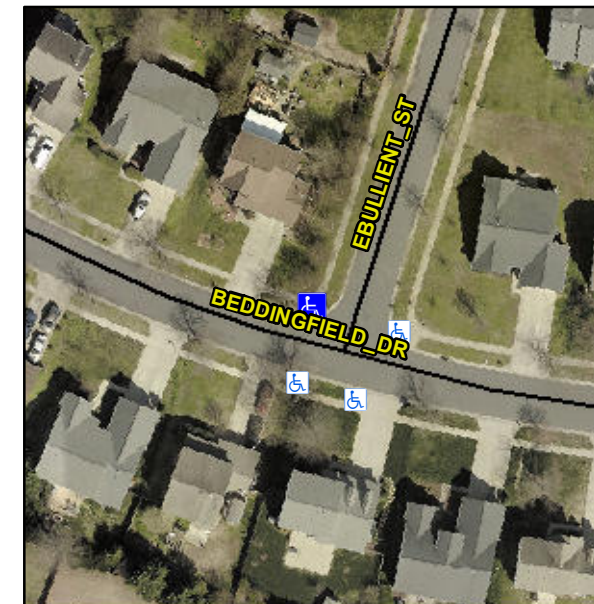
Compliance	Description	Data	Compliance	Description	Data
N/A	Ramp Length (in)	82.0	No	Ramp Slope (%)	10.7
No	Ramp Width (in)	31.0	No	Ramp XSlope (%)	3.1
N/A	Flare Type LT	N/A	N/A	Flare Type RT	N/A
N/A	Flare Slope LT (%)	N/A	N/A	Flare Slope RT (%)	N/A
N/A	Flare Traversable LT?	N/A	N/A	Flare Traversable RT?	N/A
N/A	Landing Length (in)	N/A	N/A	DWS Provided?	N/A
N/A	Landing Width (in)	N/A	N/A	DWS Contrast?	N/A
N/A	Landing Slope (%)	N/A	N/A	DWS Length (in)	N/A
N/A	Landing X Slope (%)	N/A	N/A	DWS Full Width?	N/A
N/A	Landing Curb? (Y/N)	N/A	N/A	DWS Offset (in)	N/A
N/A	Shared Landing?	N/A			
N/A	Gutter Ponding?	N/A	N/A	Gutter Slope (%)	N/A
N/A	Gutter Lip Ht (in)	N/A	N/A	Gutter X Slope (%)	N/A
N/A	Painted X Walk1?	No	N/A	Painted X Walk2?	No
	X Walk 1 Direction	To SW		X Walk 2 Direction	To SE
N/A	X Walk 1 Width (in)	N/A	N/A	X Walk 2 Width (in)	N/A
	X Walk 1 Slope (%)	4.5		X Walk 2 Slope (%)	4.6
	X Walk 1 X Slope (%)	3.5		X Walk 2 X Slope (%)	0.3

N/A	Ramp inside XWalk1?	N/A	N/A	Ramp inside XWalk2?	N/A
	Road Slope (%)	2.4	N/A	Clear Space?	N/A
	Road X Slope (%)	5.4	N/A	Clear Space to XWalk (in)	N/A
N/A	Any Obstructions?	N/A	N/A	Storm Grate/Utility Hazard?	N/A
	Obstruction Type			Storm Grate/Utility Type	
		N/A			N/A
			Yes	Surface Condition? (G/P)	Good

Remove & Replace Curb Ramp With Two New Directional Ramps or Equivalent.

R304.5.1, R304.2.2, R304.5.3
