# Access Compliance Report

## Public Rights-of-Way

### (Curb Ramps)

Intersection ID: 15116	Main Street: EUCLID_AV	Cross Street: IDEAL_WY	Location: N
ADA ID: 78857CCB8F24	Ramp Type: Directional1	Initial Pass/Fail: Fail	Overall Compliance: No
			Severity Score: 26.25

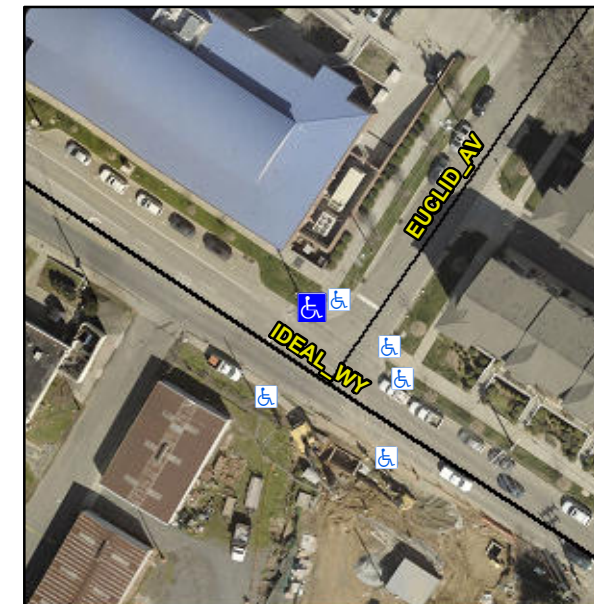
Compliance	Description	Data	Compliance	Description	Data
N/A	Ramp Length (in)	115.0	N/A	Grade Break?	N/A
Yes	Ramp Width (in)	72.0	N/A	Grade Break Slope (%)	0.0
No	Ramp Slope (%)	15.7	N/A	Grade Break XSlope (%)	0.0
No	Ramp XSlope (%)	4.7			
N/A	Flare Type LT	N/A	N/A	Flare Type RT	N/A
N/A	Flare Slope LT (%)	N/A	N/A	Flare Slope RT (%)	0.0
N/A	Flare Traversable LT?	N/A	N/A	Flare Traversable RT?	N/A
N/A	Landing Length (in)	0.0	N/A	DWS Provided?	N/A
N/A	Landing Width (in)	0.0	N/A	DWS Contrast?	N/A
N/A	Landing Slope (%)	0.0	N/A	DWS Length (in)	N/A
N/A	Landing X Slope (%)	0.0	N/A	DWS Full Width?	N/A
N/A	Landing Curb? (Y/N)	N/A	N/A	DWS Offset LT (in)	N/A
N/A	Shared Landing?	N/A	N/A	DWS Offset RT (in)	N/A
N/A	Gutter Ponding?	0.0	N/A	Gutter Slope (%)	N/A
N/A	Gutter Lip Ht (in)	0.0	N/A	Gutter X Slope (%)	N/A
N/A	Painted X Walk1?	No		Road Slope (%)	2.3
	X Walk 1 Direction	To SW		Road X Slope (%)	1.4
	X Walk 1 Width (in)	N/A		Clear Space?	N/A

X Walk 1 Slope (%)	2.3	N/A	Clear Space to XWalk (in)	N/A
	X Walk 1 X Slope (%)	1.4	N/A	Storm Grate/Utility Hazard?	N/A
N/A	Ramp inside XWalk1?	N/A		Storm Grate/Utility Type	
N/A	Any Obstructions?	N/A			N/A
	Obstruction Type		Yes	Surface Condition? (G/P)	Good
			N/A	Curb Slope (%)	4.3

**Remove & Replace Entire Ramp.**
