Access Compliance Report

Public Rights-of-Way

(Curb Ramps)

Intersection ID: 19936	Main Street: ARCHDALE_DR	Cross Street: CHERRYCREST_LN	Location: NW
ADA ID: 788B5C6DD802	Ramp Type: PerpDiag	Initial Pass/Fail: Fail	Overall Compliance: No
Codes/Mitigation Info/Possible Solution		Field Measurements/Component Compliance

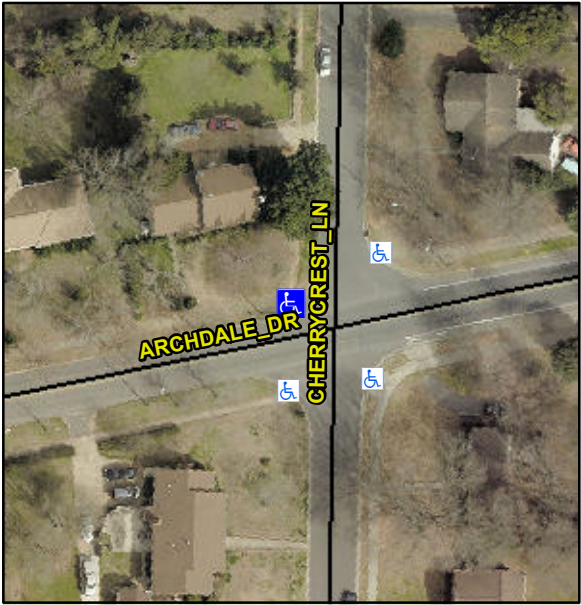
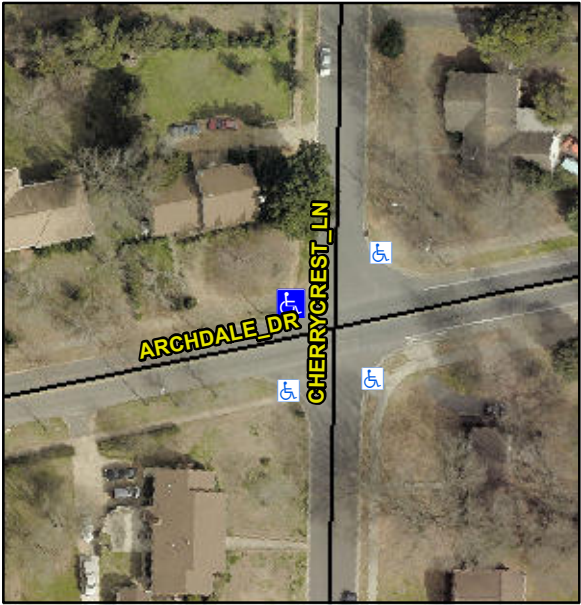
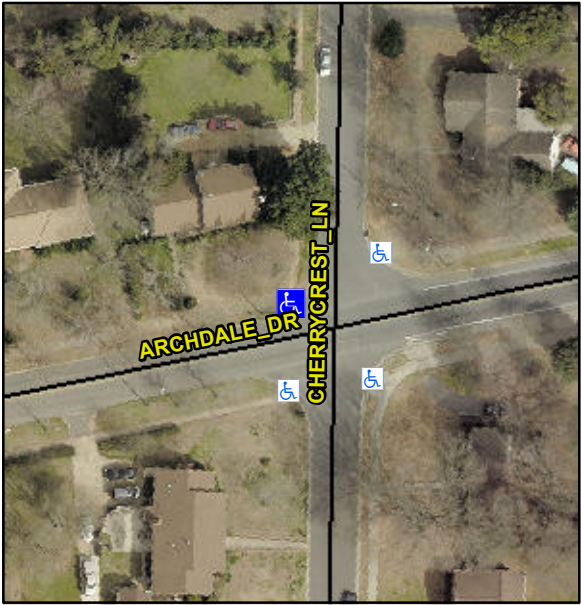
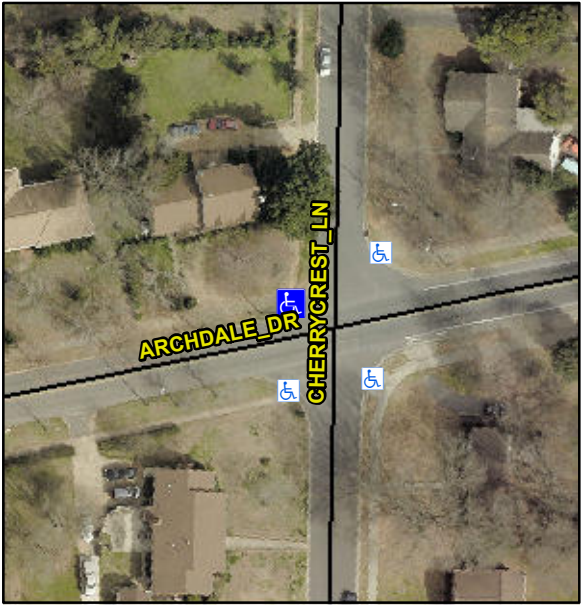
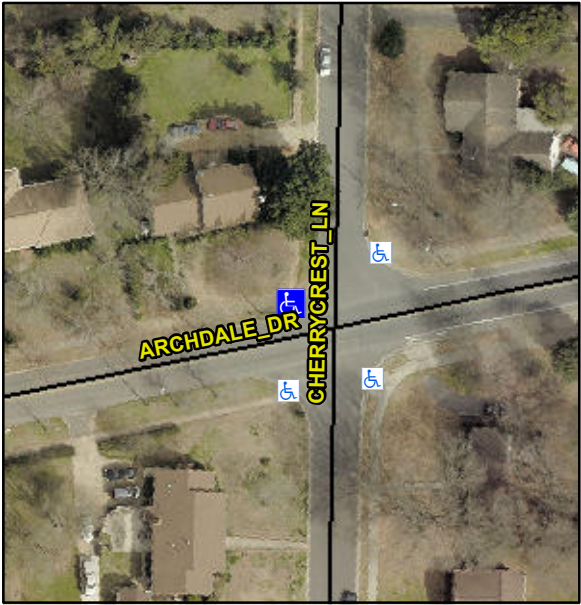
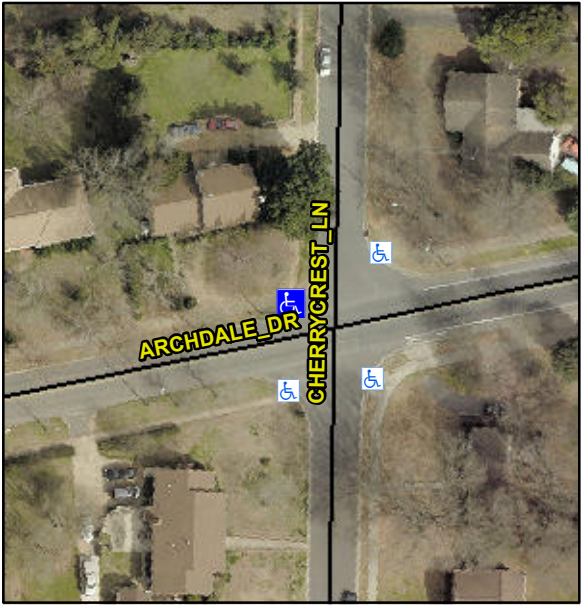
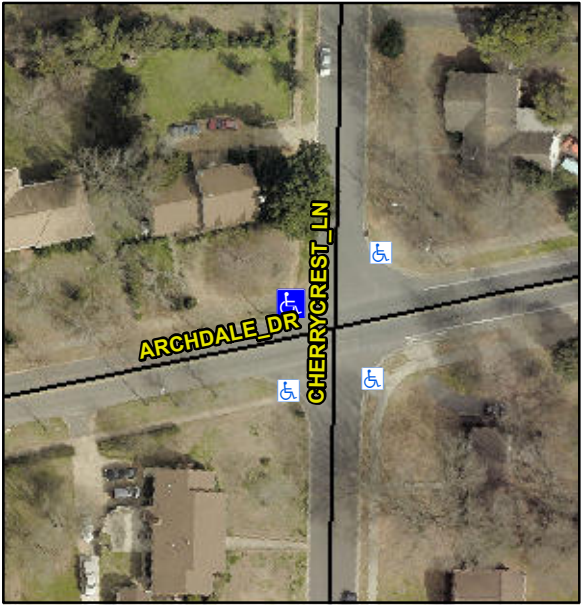
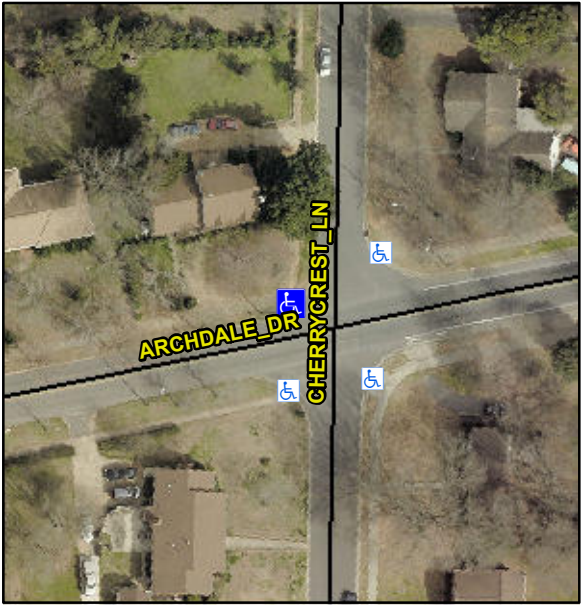
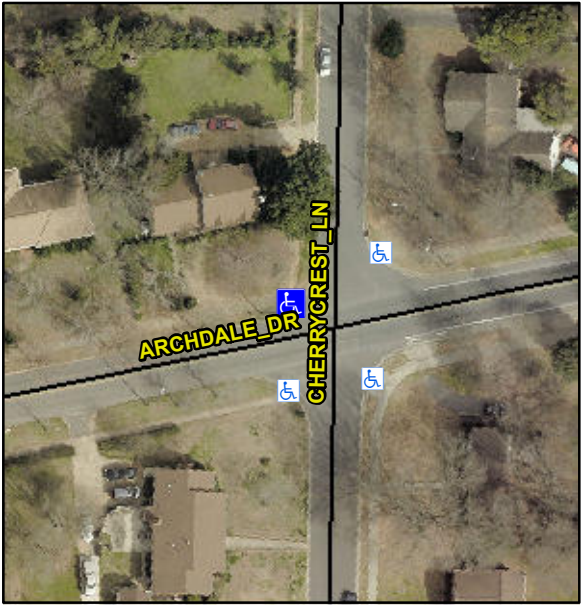
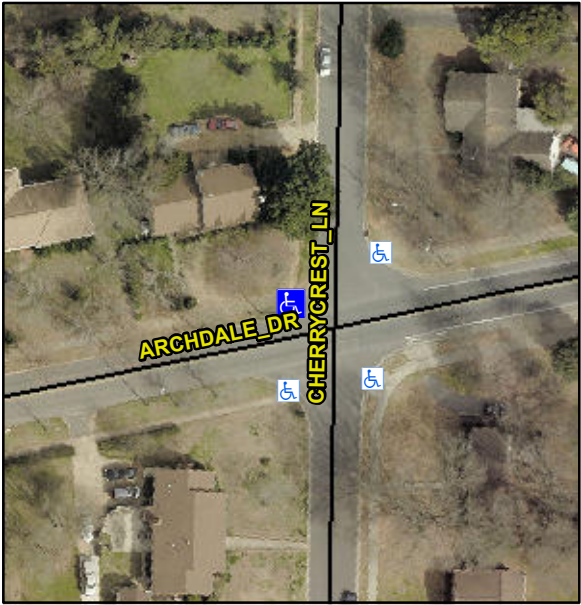
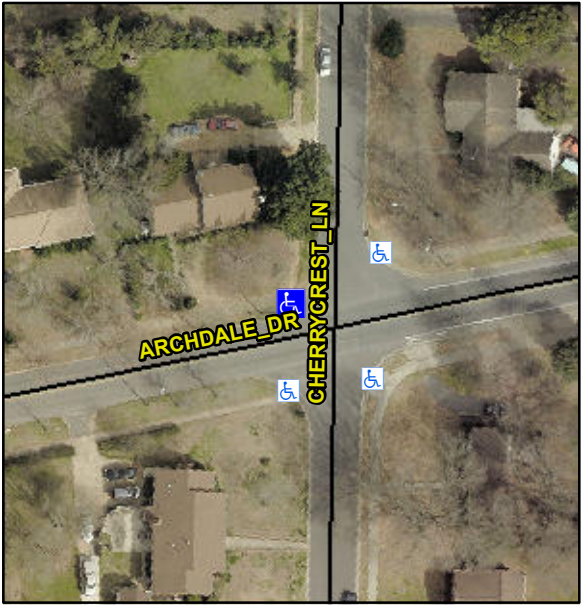
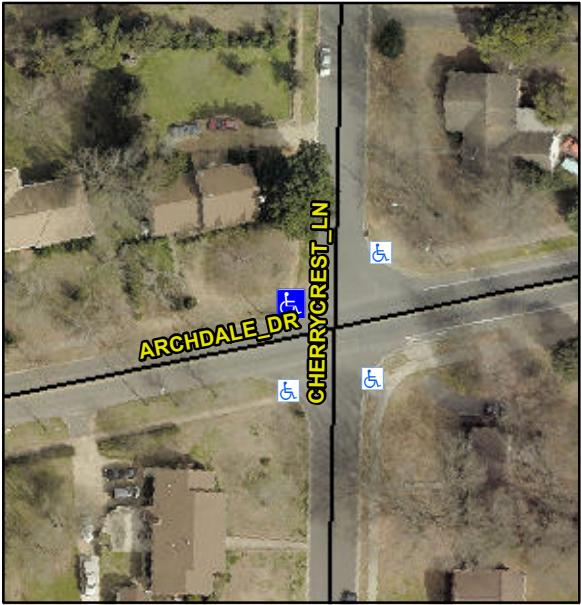
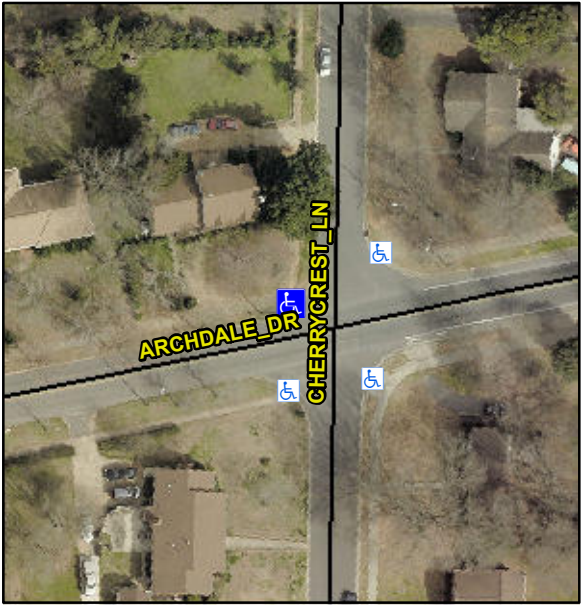
Possible Solutions:		Compliance		Description		Data	Compliance	Description	Data
	Remove & Replace Curb Ramp With Two New Directional Ramps or Equivalent.		N/A		Ramp Length (in)		73.0	Yes	Ramp Slope (%)	6.4

Surveyor Notes:		No		Ramp Width (in)		46.5	No	Ramp XSlope (%)	6.1
	N/A		N/A		Flare Type LT		N/A	N/A	Flare Type RT	N/A

PROW/ADA:		N/A		Flare Slope LT (%)		N/A	N/A	Flare Slope RT (%)	N/A
	Not Found, R304.5.1, R304.5.3		N/A		Flare Traversable LT?		N/A	N/A	Flare Traversable RT?	N/A

Total Cost:		N/A		Landing Length (in)		N/A	N/A	DWS Provided?	N/A
	\$ 3200.00		N/A		Landing Width (in)		N/A	N/A	DWS Contrast?	N/A
