Access Compliance Report

Public Rights-of-Way

(Curb Ramps)

| Intersection ID: 53181 | Main Street: GOODMAN_PARK_CT | Cross Street: BASIE_PARK_CT | Location: NW |

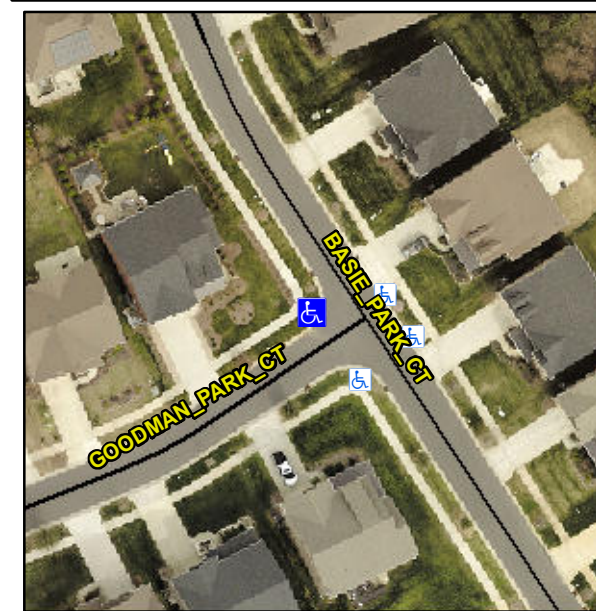
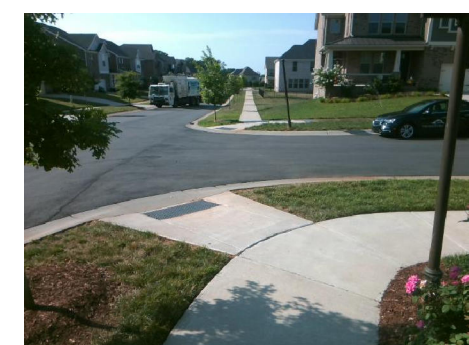
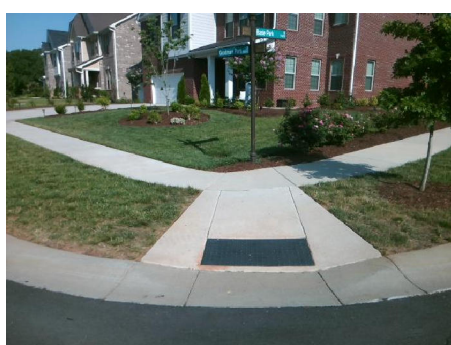
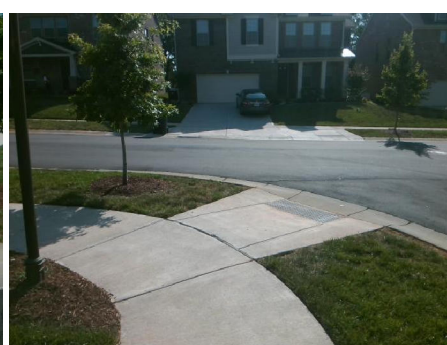
| ADA ID: 78AEAE1884FC | Ramp Type: PerpDiag | Initial Pass/Fail: Fail | Overall Compliance: No |
| Severity Score: 33.75 | | | |

R304.5.1, R304.2.2, R304.5.3

| Compliance | Description | Data | Compliance | Description | Data |
|---|---|---|---|---|---|
| N/A | Ramp Length (in) | 97.0 | No | Ramp Slope (%) | 11.3 |
| No | Ramp Width (in) | 45.0 | No | Ramp XSlope (%) | 5.5 |

Remove & Replace Curb Ramp With Two New Directional Ramps or Equivalent.

Total Cost: \$ 3200.00
