Access Compliance Report

Public Rights-of-Way

(Curb Ramps)

Intersection ID: 12519	Main Street: E_6TH_ST	Cross Street: N_CALDWELL_ST	Location: W
ADA ID: 78B339EB8FDD	Ramp Type: PerpDiag	Initial Pass/Fail: Fail	Overall Compliance: No
			Severity Score: 26.25

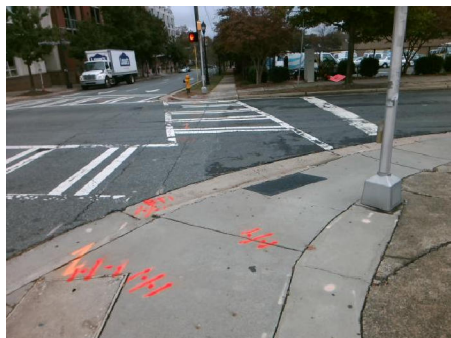
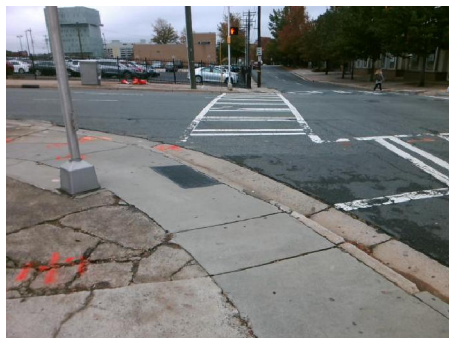
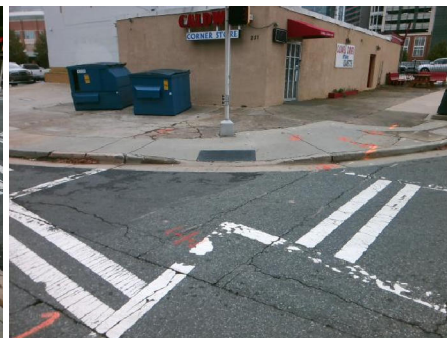
Compliance	Description	Data	Compliance	Description	Data
N/A	Ramp Length (in)	61.0	No	Ramp Slope (%)	12.9
Yes	Ramp Width (in)	50.0	No	Ramp XSlope (%)	3.9
N/A	Flare Type LT	N/A	N/A	Flare Type RT	N/A
N/A	Flare Slope LT (%)	N/A	N/A	Flare Slope RT (%)	N/A
N/A	Flare Traversable LT?	N/A	N/A	Flare Traversable RT?	N/A
N/A	Landing Length (in)	N/A	N/A	DWS Provided?	N/A
N/A	Landing Width (in)	N/A	N/A	DWS Contrast?	N/A
N/A	Landing Slope (%)	N/A	N/A	DWS Length (in)	N/A
N/A	Landing X Slope (%)	N/A	N/A	DWS Full Width?	N/A
N/A	Landing Curb? (Y/N)	N/A	N/A	DWS Offset (in)	N/A
N/A	Shared Landing?	N/A			
N/A	Gutter Ponding?	N/A	N/A	Gutter Slope (%)	N/A
N/A	Gutter Lip Ht (in)	0.5	N/A	Gutter X Slope (%)	N/A
N/A	Painted X Walk1?	Yes	N/A	Painted X Walk2?	Yes
	X Walk 1 Direction	To SE		X Walk 2 Direction	To NE
N/A	X Walk 1 Width (in)	100.0	N/A	X Walk 2 Width (in)	102.0
	X Walk 1 Slope (%)	2.5		X Walk 2 Slope (%)	3.7
	X Walk 1 X Slope (%)	1.8		X Walk 2 X Slope (%)	1.4

N/A	Ramp inside XWalk1?	Yes	N/A	Ramp inside XWalk2?	Yes
	Road Slope (%)	1.8	N/A	Clear Space?	N/A
	Road X Slope (%)	0.1	N/A	Clear Space to XWalk (in)	N/A
N/A	Any Obstructions?	N/A	N/A	Storm Grate/Utility Hazard?	N/A
	Obstruction Type			Storm Grate/Utility Type	
		N/A			N/A
		Yes		Surface Condition? (G/P)	Good

Remove & Replace Curb Ramp With Two New Directional Ramps or Equivalent.
