Access Compliance Report

Public Rights-of-Way

(Curb Ramps)

Intersection ID: 17580	Main Street: N_SHARON_AMITY_RD	Cross Street: WALKER_RD	Location: NW
ADA ID: 78B68BA02802	Ramp Type: PerpDiag	Initial Pass/Fail: Fail	Overall Compliance: No Severity Score: 31.25

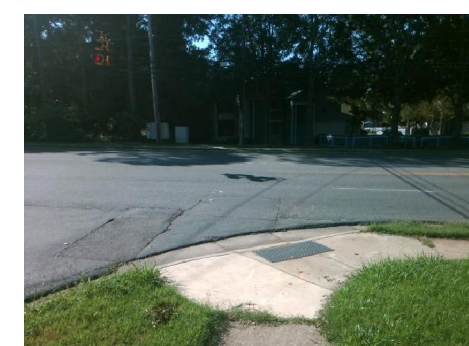
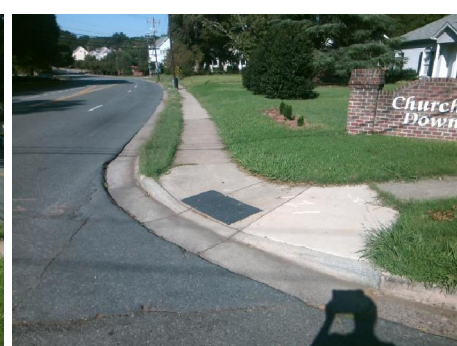
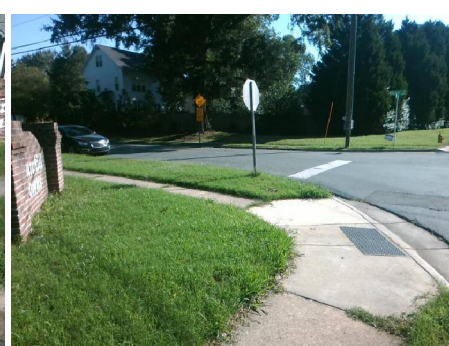
N/A	X Walk 2 Width (in)	N/A
			2.0	X Walk 2 Slope (%)	3.8
			4.8	X Walk 2 X Slope (%)	0.9
			N/A	Ramp inside XWalk2?	N/A
			3.0	Clear Space?	N/A
			1.7	Clear Space to XWalk (in)	N/A
			N/A	Storm Grate/Utility Hazard?	N/A
			N/A	Storm Grate/Utility Type	N/A
			N/A	Surface Condition? (G/P)	Good

Possible Solutions:		Compliance	Description	Data
	Remove & Replace Curb Ramp With Two New Directional Ramps or Equivalent.		No	Ramp Length (in)	69.0
			No	Ramp Width (in)	32.0
			N/A	Flare Type LT	N/A
			N/A	Flare Slope LT (%)	N/A
			N/A	Flare Traversable LT?	N/A
			N/A	Landing Length (in)	N/A
			N/A	Landing Width (in)	N/A
			N/A	Landing Slope (%)	N/A
			N/A	Landing X Slope (%)	N/A
<p>Surveyor Notes:</p> <p>N/A</p> <p>PROW/ADA:</p> <p>Not Found, R304.5.1, R304.2.2, R304.5.3</p>			N/A	Flare Type RT	N/A
			N/A	Flare Slope RT (%)	N/A
			N/A	Flare Traversable RT?	N/A
			N/A	DWS Provided?	N/A
			N/A	DWS Contrast?	N/A
			N/A	DWS Length (in)	N/A
			N/A	DWS Full Width?	N/A
			N/A	DWS Offset (in)	N/A
			N/A	Gutter Ponding?	N/A
			N/A	Gutter Lip Ht (in)	N/A
<p>Total Cost:</p> <p>\$ 3200.00</p>			No	Painted X Walk1?	No
			To S	X Walk 2 Direction	To E
