## **Access Compliance Report Public Rights-of-Way** (Curb Ramps)

Intersection ID: 7623 Main Street: DERRYDOWNE DR **Cross Street: MONTEITH DR** Location: NW ADA ID: 78BF4FFB9BE Ramp Type: BlendTrans1 Initial Pass/Fail: Fail **Overall Compliance: No Severity Score:** 1.25

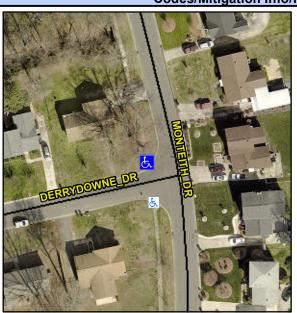
Field Measurements/Component Compliance					
Compliance Description		Data	Compliance Description		Data
N/A	Ramp Length (in)	39.5	Yes	BlendTrans Slope (%)	1.7
Yes	Ramp Width (in)	48.0	No	BlendTrans XSlope (%)	4.0
N/A	Flare Type LT	Sloped	N/A	Flare Type RT	Sloped
N/A	Flare Slope LT (%)	3.0	N/A	Flare Slope RT (%)	0.2
N/A	Flare Traversable LT?	No	N/A	Flare Traversable RT?	N/A
N/A	Landing Length (in)	N/A	N/A	DWS Provided?	Yes
N/A	Landing Width (in)	N/A	N/A	DWS Contrast?	Yes
N/A	Landing Slope (%)	N/A	N/A	DWS Length (in)	24.5
N/A	Landing X Slope (%)	N/A	N/A	DWS Full Width?	Yes
N/A	Landing Curb? (Y/N)	No	N/A	DWS Offset (in)	0.0
N/A	Shared Landing?	No			
N/A	Gutter Ponding?	Yes	N/A	Gutter Slope (%)	0.6
N/A	Gutter Lip Ht (in)	0.3	N/A	Gutter X Slope (%)	4.3
N/A	Painted X Walk1?	No	N/A	Painted X Walk2?	N/A
	X Walk 1 Direction	To S		X Walk 2 Direction	N/A
	X Walk 1 Width (in)	N/A		X Walk 2 Width (in)	N/A
	X Walk 1 Slope (%)	7.1		X Walk 2 Slope (%)	N/A

X Walk 1 X Slope (%)	2.0		X Walk 2 X Slope (%)	N/A
N/A	Ramp inside XWalk1?	N/A	N/A	Ramp inside XWalk2?	N/A
	Road Slope (%)	2.0		Clear Space?	Yes
	Road X Slope (%)	7.1	N/A	Clear Space to XWalk (in)	N/A
N/A	Any Obstructions?	No	N/A	Storm Grate/Utility Hazard?	No
	Obstruction Type			Storm Grate/Utility Type	
		N/A			N/A
			Yes	Surface Condition? (G/P)	Good
			No	Curb Slope (%)	18.5

Possible Solutions: **Remove & Replace Curb Ramp With Two New Directional Ramps or** Equivalent. Surveyor Notes: N/A PROW/ADA: Not Found, R304.5.3

Total Cost: 3200.00
