Access Compliance Report Public Rights-of-Way (Curb Ramps)

· · · ·									
Intersection ID: 23357 Main Street: SHARON_RD_		reet: SHARON_RD_WEST	EST Cross Street: SHARONBROOK_DR					Location:	SE
ADA ID: 78CA8800F1F6	ID: 78CA8800F1F6 Ramp Type: PerpDiag		Initial Pass/Fail: Fail Overall Compliance: N				nce: N	o Severity Score:	35
Codes/Mitigation Info/Possible Solution				Field Measurements/Component Compliance					
	NORTH_WIND_PL	Possible Solutions:		Compliance Description		Data Compliance Description		Data	
a state	Reisting Parket a	Remove & Replace Curb Ramp	With	N/A	Ramp Length (in)	60.0	No	Ramp Slope (%)	12.3
		Two New Directional Ramps or Equivalent.		No	Ramp Width (in)	39.0	No	Ramp XSlope (%)	3.0
				N/A	Flare Type LT	N/A	N/A	Flare Type RT	N/A
				N/A	Flare Slope LT (%)	N/A	N/A	Flare Slope RT (%)	N/A
SHARON	6.			N/A	Flare Traversable LT?	N/A	N/A	Flare Traversable RT?	N/A
	ND_WEST			N/A	Landing Length (in)	N/A	N/A	DWS Provided?	N/A
Contraction of the second seco		Surveyor Notes:		N/A	Landing Width (in)	N/A	N/A	DWS Contrast?	N/A

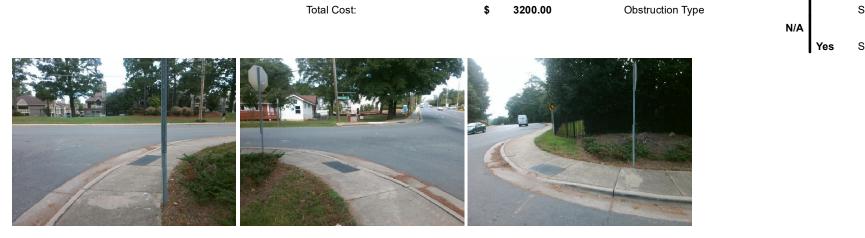
A MARKED -	N/A		N/A	Landing Slope (%)	N/A	N/A	DWS Length (in)	N/A
				N/A	Landing X Slope (%)	N/A	N/A	DWS Full Width?	N/A
		4		N/A	Landing Curb? (Y/N)	N/A	N/A	DWS Offset (in)	N/A
	Mr. A. A.			N/A	Shared Landing?	N/A			
		PROW/ADA:		N/A	Gutter Ponding?	N/A	N/A	Gutter Slope (%)	N/A
		Not Found, R304.5.1, R304.2.2,		N/A	Gutter Lip Ht (in)	N/A	N/A	Gutter X Slope (%)	N/A
	O KARA	R304.5.3		N/A	Painted X Walk1?	No	N/A	Painted X Walk2?	No
	a product of the second				X Walk 1 Direction	To N		X Walk 2 Direction	To NW
				N/A	X Walk 1 Width (in)	N/A	N/A	X Walk 2 Width (in)	N/A
Street 1 Name	SHARON RD WEST	_			X Walk 1 Slope (%)	2.9		X Walk 2 Slope (%)	1.0
Stop Condition-Street 2	None				X Walk 1 X Slope (%)	0.0		X Walk 2 X Slope (%)	3.6
Street 2 Name	SHARONBROOK DR			N/A	Ramp inside XWalk1?	N/A	N/A	Ramp inside XWalk2?	N/A
Stop Condition-Street 1	StopSign				Road Slope (%)	4.2	N/A	Clear Space?	N/A
					Road X Slope (%)	4.5	N/A	Clear Space to XWalk (in)	N/A

N/A	Any Obstructions?	N/A	N/A	Storm Grate/Utility Hazard?	N/A
		Total Cost: \$	3200.00		Obstruction Type			Storm Grate/Utility Type	
						N/A			N/A
							1
