Access Compliance Report

Public Rights-of-Way

(Curb Ramps)

Intersection ID: 6473	Main Street: MINERAL_SPRINGS_RD	Cross Street: N_GRAHAM_ST	Location:	N
ADA ID: 78D043E56057	Ramp Type: Perp	Initial Pass/Fail: Fail	Overall Compliance: No	Severity Score: 22.5
Codes/Mitigation Info/Possible Solution		Field Measurements/Component Compliance

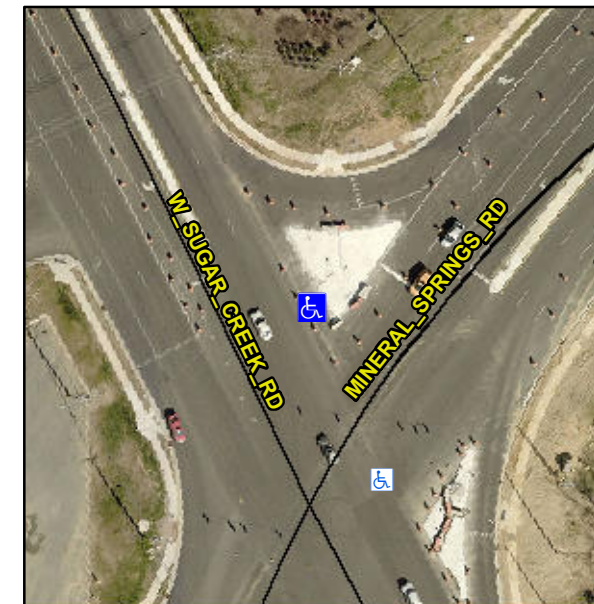
R304.5.1, R304.2.2, R304.5.3

Compliance	Description	Data	Compliance	Description	Data
N/A	Ramp Length (in)	61.0	No	Ramp Slope (%)	9.5
No	Ramp Width (in)	37.0	No	Ramp XSlope (%)	2.6
N/A	Flare Type LT	N/A	N/A	Flare Type RT	N/A
N/A	Flare Slope LT (%)	N/A	N/A	Flare Slope RT (%)	N/A
N/A	Flare Traversable LT?	N/A	N/A	Flare Traversable RT?	N/A
N/A	Landing Length (in)	N/A	N/A	DWS Provided?	N/A
N/A	Landing Width (in)	N/A	N/A	DWS Contrast?	N/A
N/A	Landing Slope (%)	N/A	N/A	DWS Length (in)	N/A
N/A	Landing X Slope (%)	N/A	N/A	DWS Full Width?	N/A
N/A	Landing Curb? (Y/N)	N/A	N/A	DWS Offset (in)	N/A
N/A	Shared Landing?	N/A			
N/A	Gutter Ponding?	N/A	N/A	Gutter Slope (%)	N/A
N/A	Gutter Lip Ht (in)	N/A	N/A	Gutter X Slope (%)	N/A
N/A	Painted X Walk1?	No	N/A	Painted X Walk2?	N/A
	X Walk 1 Direction	To S		X Walk 2 Direction	N/A
N/A	X Walk 1 Width (in)	N/A	N/A	X Walk 2 Width (in)	N/A
	X Walk 1 Slope (%)	2.3		X Walk 2 Slope (%)	N/A
	X Walk 1 X Slope (%)	0.7		X Walk 2 X Slope (%)	N/A

N/A	Ramp inside XWalk1?	N/A	N/A	Ramp inside XWalk2?	N/A
	Road Slope (%)	N/A	N/A	Clear Space?	N/A
	Road X Slope (%)	N/A	N/A	Clear Space to XWalk (in)	N/A
N/A	Any Obstructions?	N/A	N/A	Storm Grate/Utility Hazard?	N/A
	Obstruction Type			Storm Grate/Utility Type	
		N/A			N/A
			Yes	Surface Condition? (G/P)	Good

Possible Solutions:

Remove & Replace Entire Ramp.
